# HMS HAMPSHIRE 100

Survey Report

## HMS HAMPSHIRE 100 Survey Report

Location:            Atlantic Ocean, waters west of Orkney, Scotland

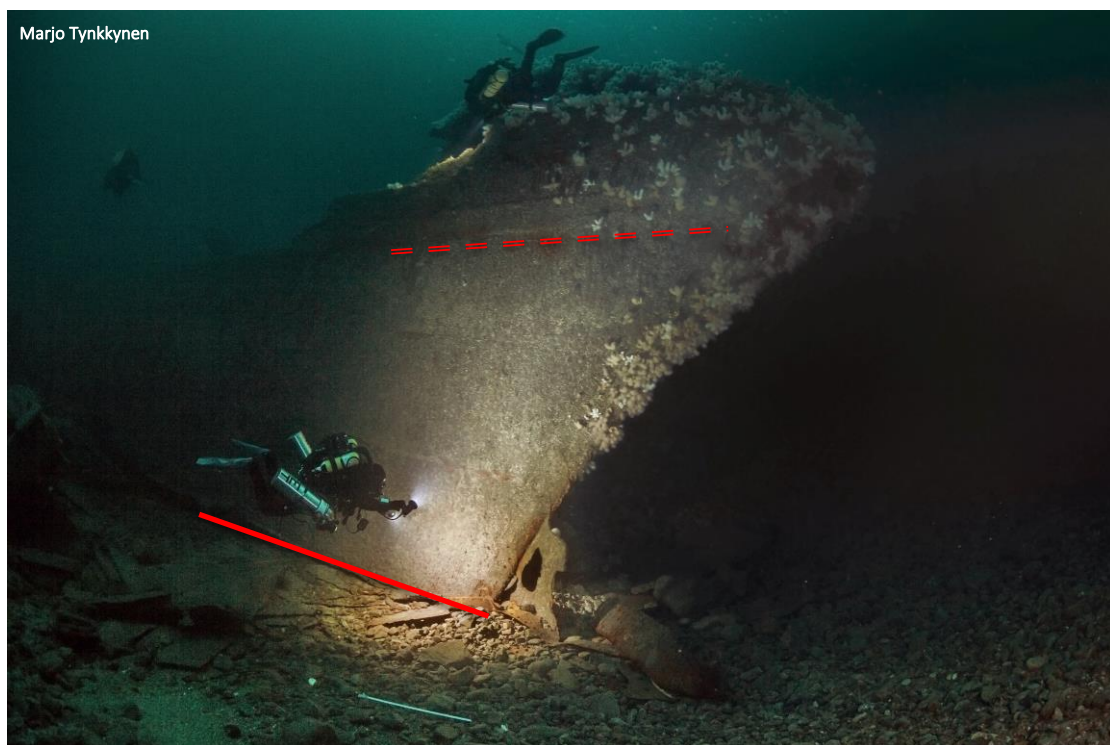
*Figure 34: The intact stem – to right of shot. Damage to her keel can be seen top left*

In Figure 34, the lower single red line delineates the top of the vertical armour belt. The top dashed red lines delineate the bottom of the armour belt. The two deck levels formerly above the belt have been crushed.

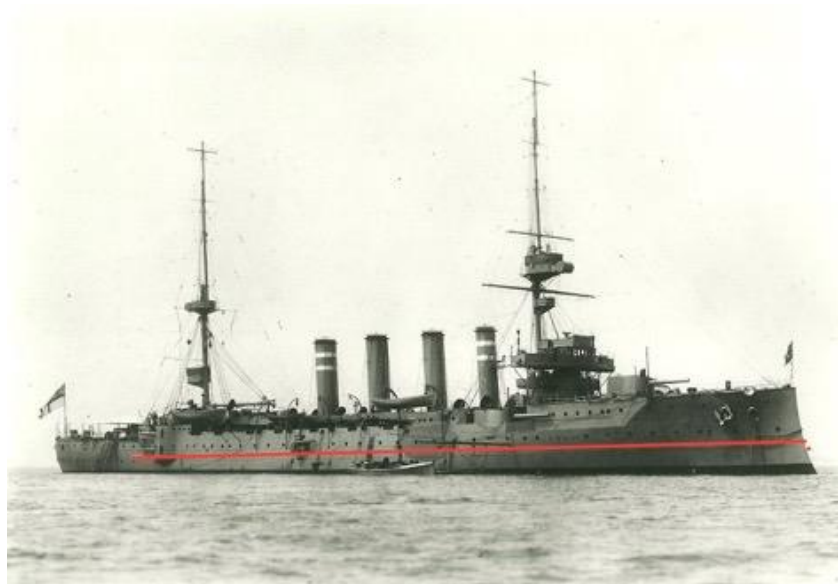
Figure 35: The red line delineates the top of the waterline main armour belt

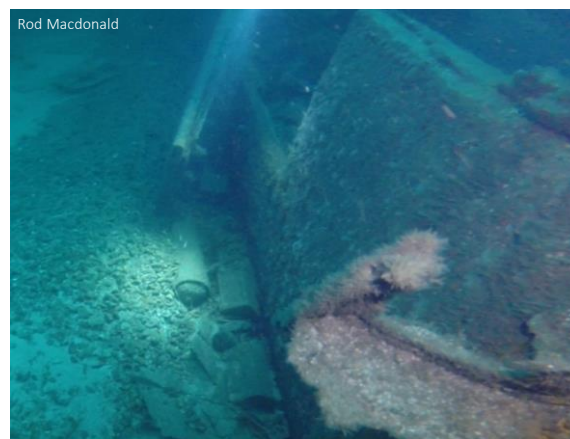
- One section of armour belt plate on the starboard side has been displaced and now rests on the seabed above a possible torpedo body.

*Figure 39: Armour belt*

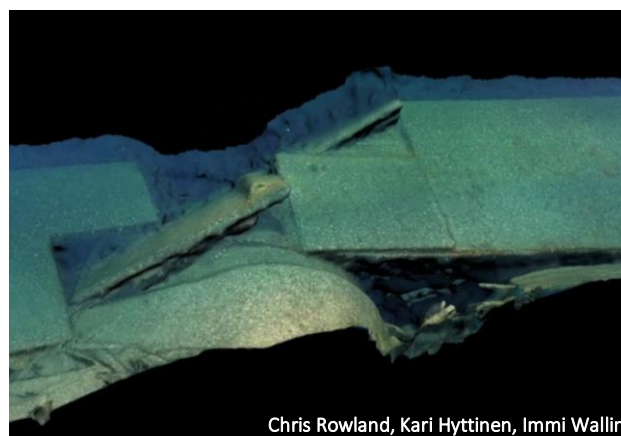
- On the port side adjacent to A-turret plates have been displaced. Inside the damaged area at this point the ammunition hoist trunking is intact and still attached to A-turret, although it now leans to starboard.

*Figure 40: 3D image of port side displaced armour plate near A-turret*

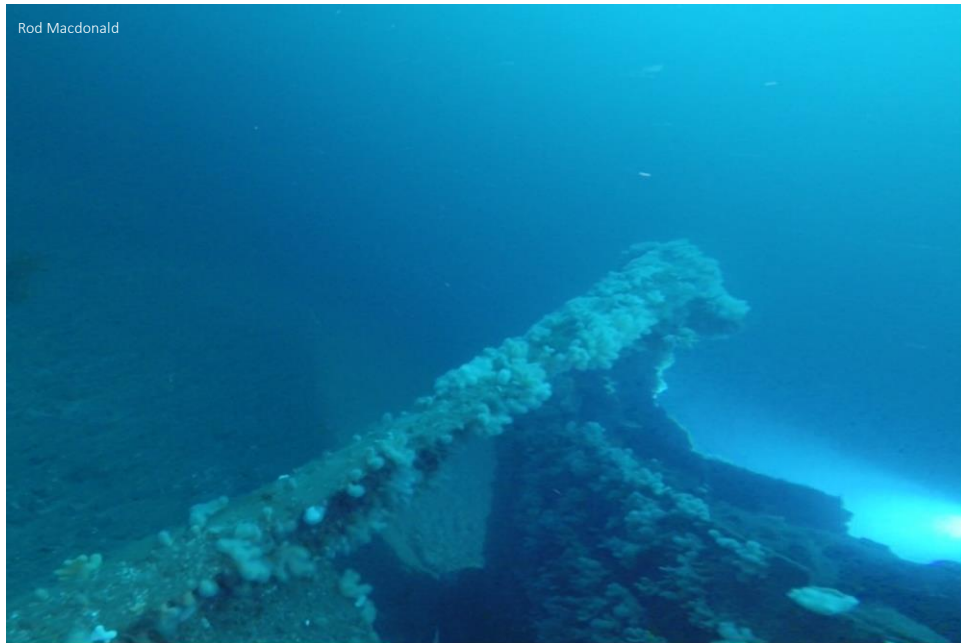
*Figure 43: Starboard view of bow showing severed keel*

Lying on the seabed surrounding the bow are many pieces of hull plating. The majority of these lie under the broken keel on the starboard side.

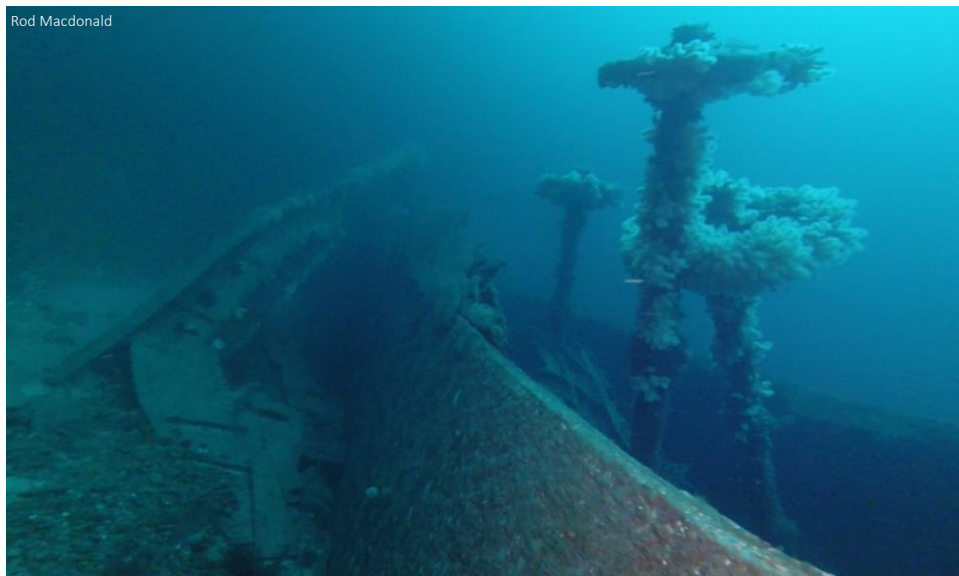
*Figure 44: Wide angle starboard view of severed keel*

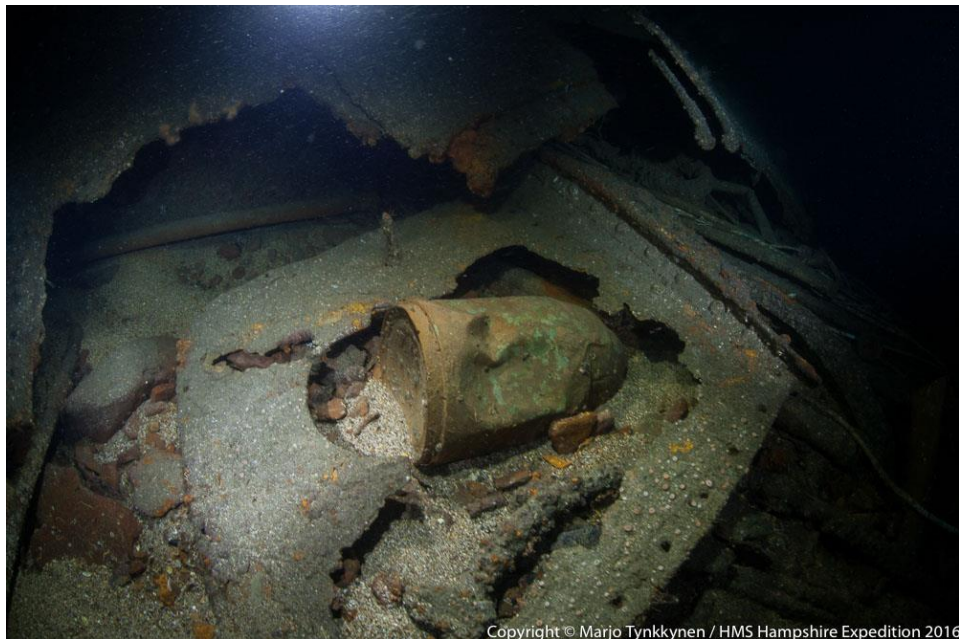
*Figure 56: A brass torpedo warhead casing showing hydrostatic pressure damage (The degree of damage suggests the warhead is not loaded with explosive and might be for drill or practice)*

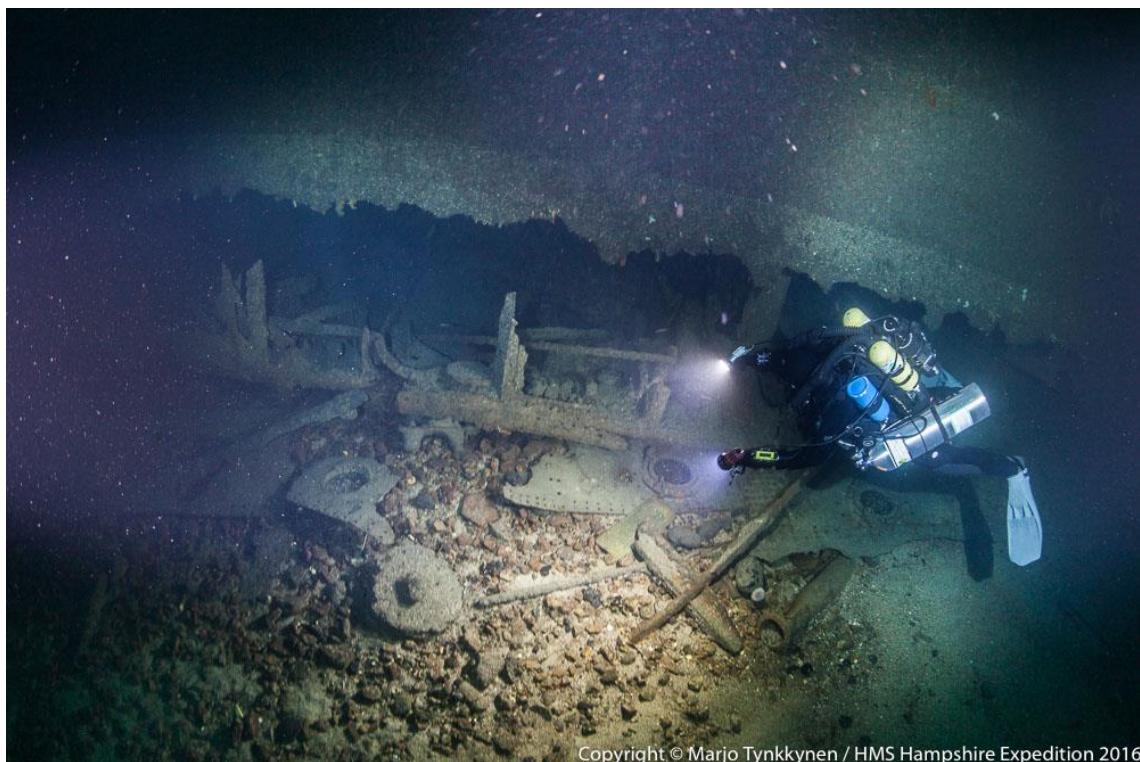
*Figure 68: Hull plating has decayed and fallen away from the Main Deck on the starboard side, leaving portholes on the seabed*

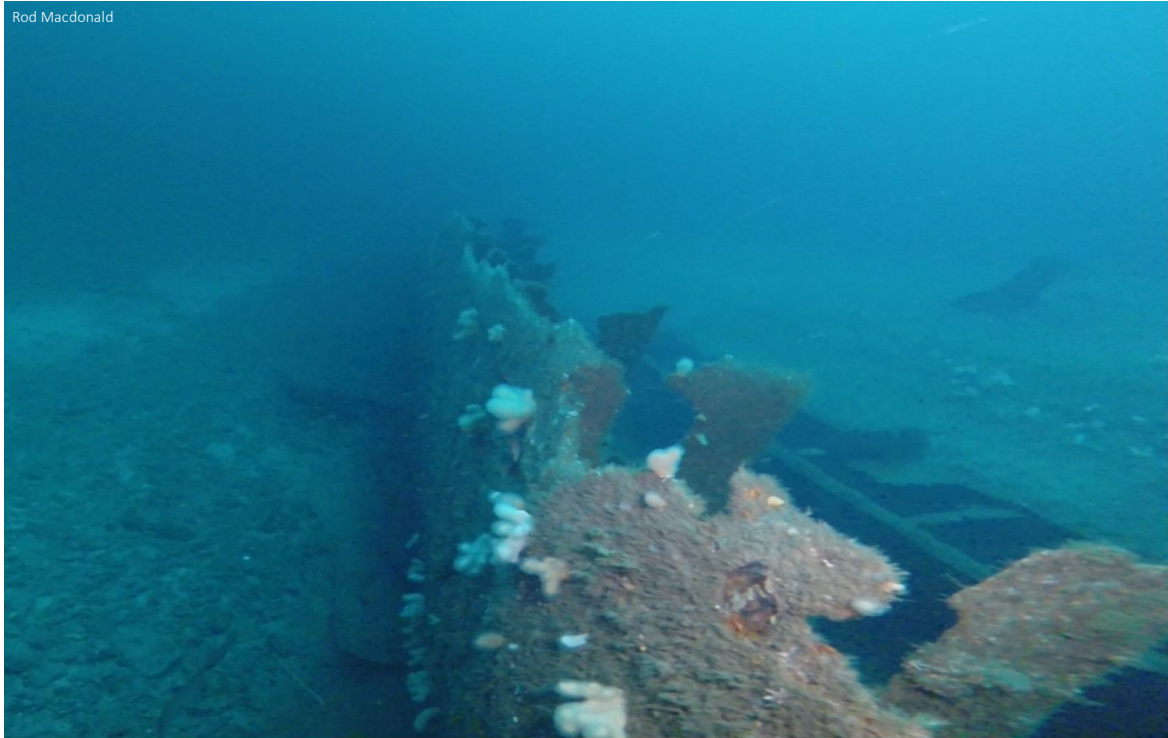
*Figure 76: Looking forward along starboard side - fissure in the hull*

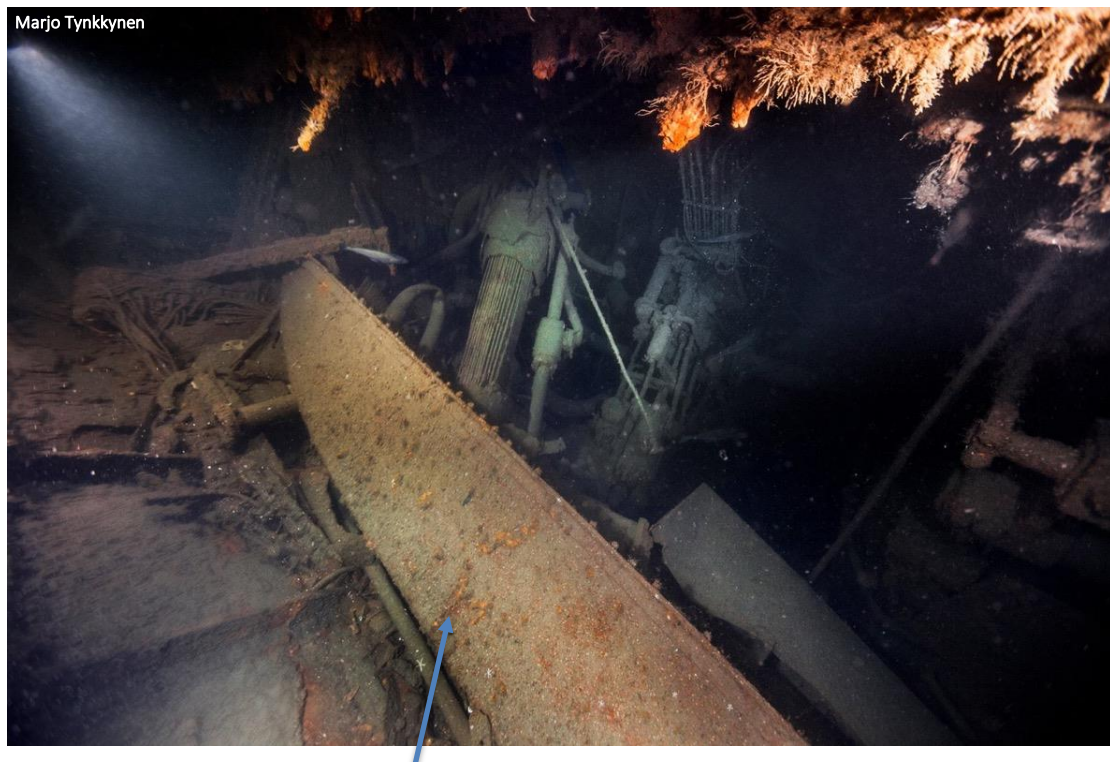
Both bilge keels remain on the ship, although the aft section on the port side has broken and fallen into the fissure and now lies alongside condensers and evaporators.

Figure 79: The aft end of the port bilge keel is visible in the fissure lying alongside evaporators

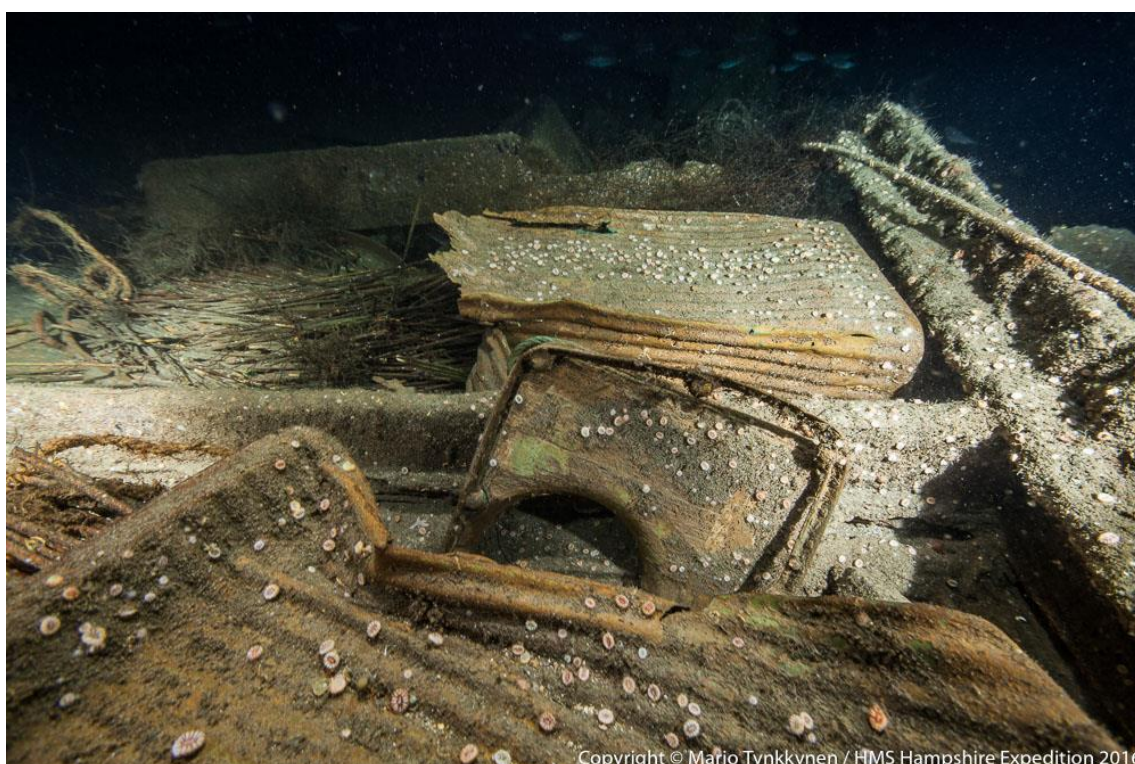
*Figure 105: Ribbed flash proof brass cordite cases for 7.5" or 6" BL guns. These cases have sustained hydrostatic pressure damage and have burst open, spilling cordite sticks from within. The cordite would have been contained in silk bags, which have evidently rotted away*

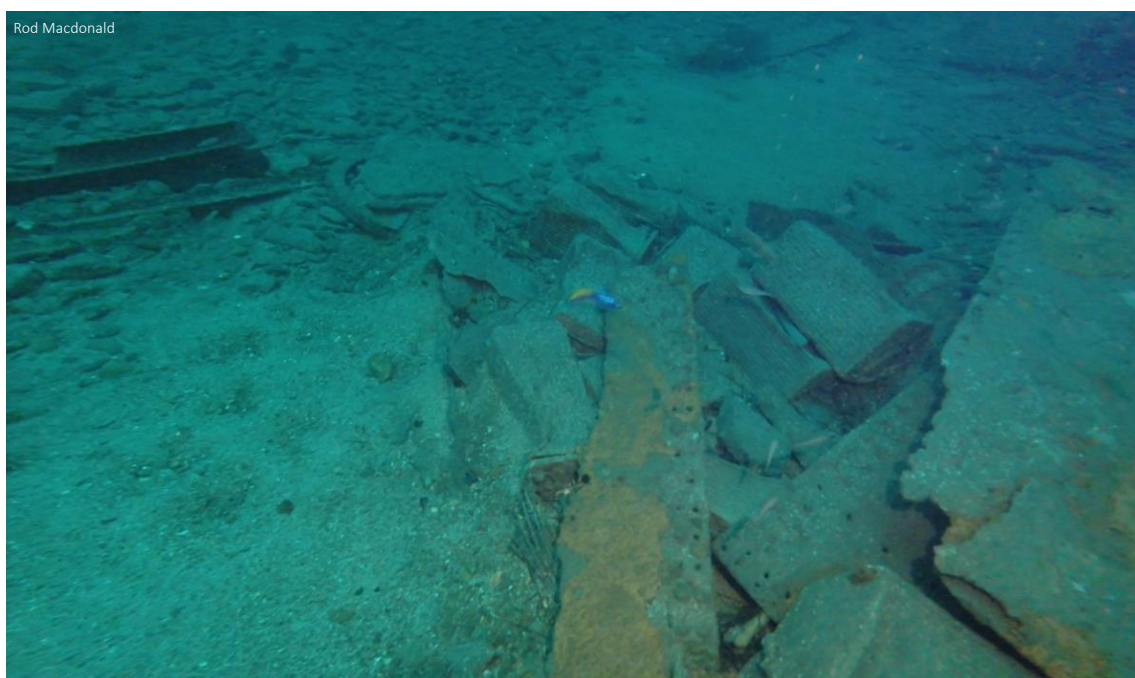
*Figure 107: Boxes of cordite have fallen from the fissure on the port side to lie on the seabed*

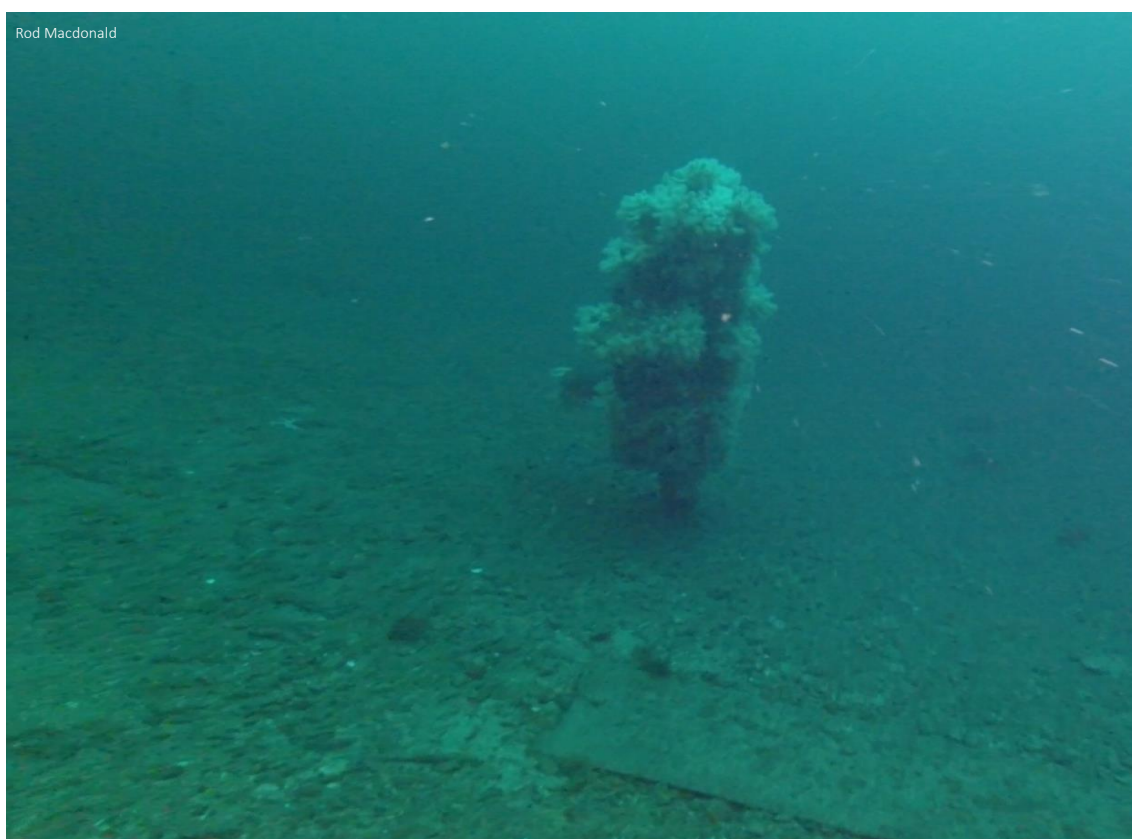
Figure 115: A 6-inch Vickers Mk VII gun has fallen from its mount as the ship capsized and impaled itself barrel first in the seabed

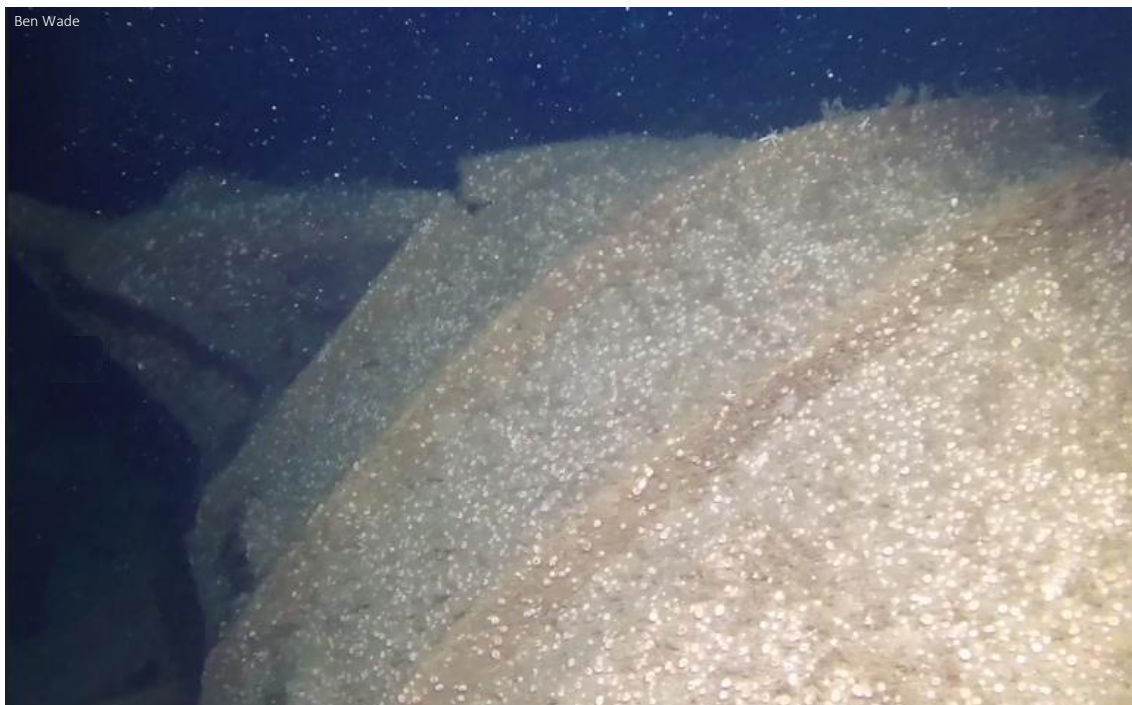
*Figure 121: Bulkhead looking to port across the ship: note the cracking damage*

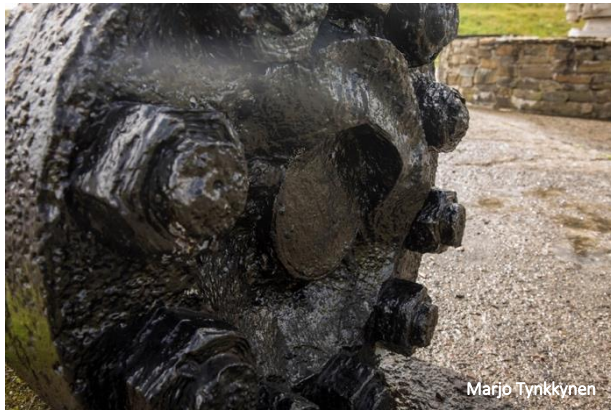
*Figure 123: The broken flange joint of the starboard side prop shaft housed at Sapa Flow Visitor Centre*

- The fracture surface of the propeller shaft where it is broken from the ship is adjacent to a bolted flange joint.
- There is no sign of blast damage to the bolted joint or flange.
- There is evidence of cup and cone fracture surfaces consistent with a bending fracture mechanism. Essentially, it has bent and snapped either when the ship hit the seabed or subsequently as the ship has decayed, or possibly through illegal, commercial salvage works.
- The current condition of the port propeller shaft on the ship shows signs of stress consistent with the location of the break on the starboard shaft on the ship.

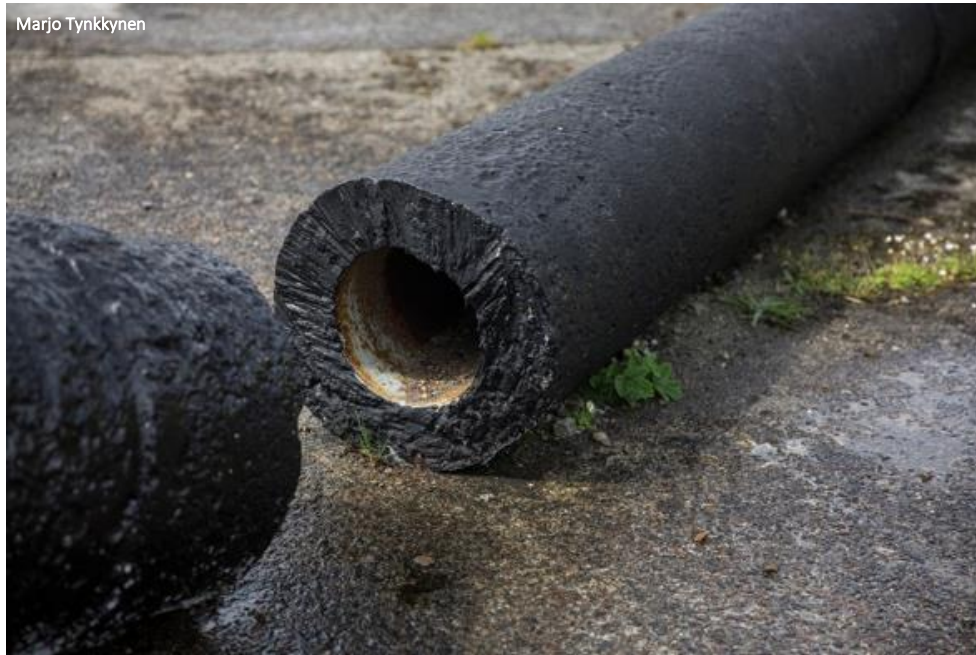
*Figure 124: The starboard shaft was cut just aft of the propeller post-salvage*

- The starboard shaft has been cut just forward of where the cutlass bearing would have been. This cut has been made post salvage, as archive images of the landed artefact show the shaft and propeller as a composite unit. It is suggested that the cut may have been made in order to ship the items to Lyness.

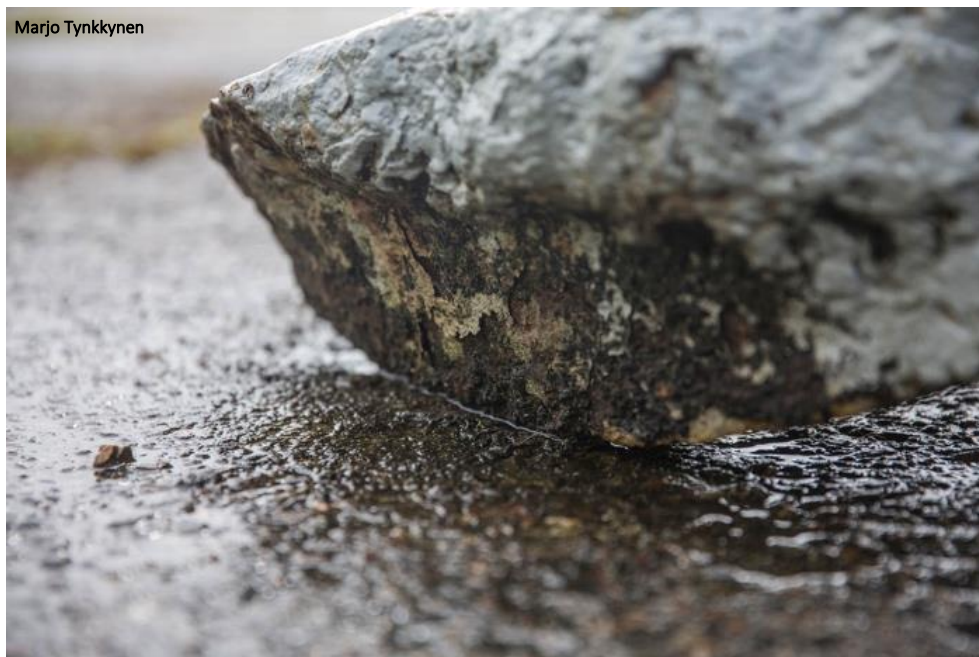
*Figure 126: Fracture surface of A-frame*

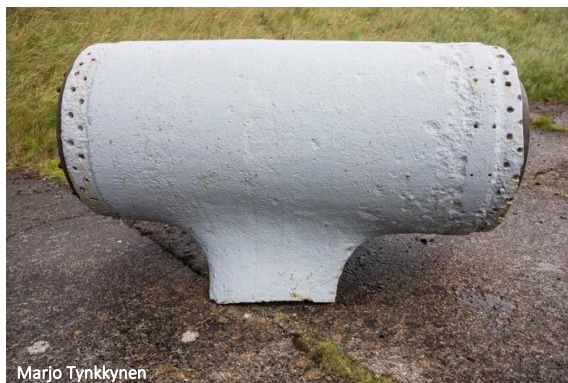
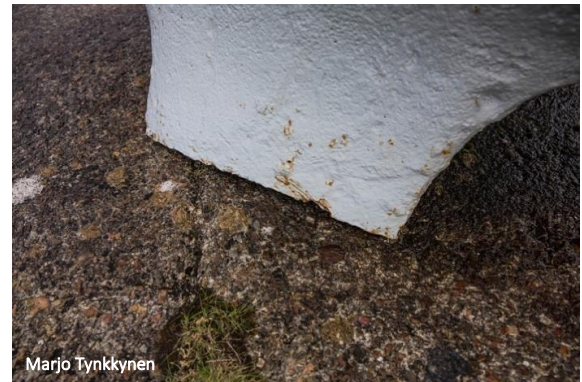
*Figure 127: Starboard side A-frame bracket showing the severed short arm*
