# HMS HAMPSHIRE 100

Survey Report

## HMS HAMPSHIRE 100 Survey Report

Location:            Atlantic Ocean, waters west of Orkney, Scotland

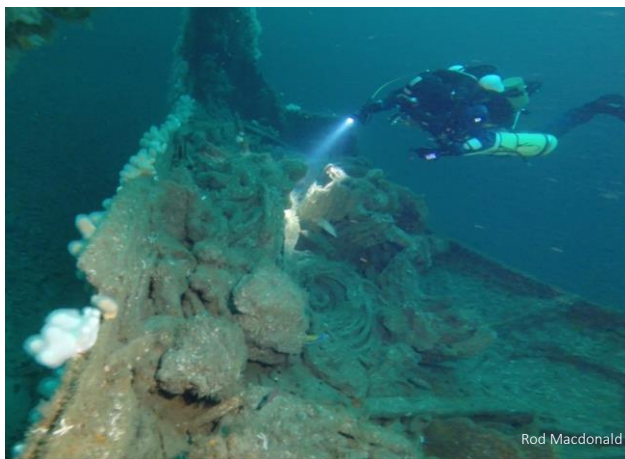
*Figure 37: Looking forwards to the upturned stem*

Looking forward towards the upturned stem (Figure 37), fragments of hull plating can be seen on the starboard (left) side of the ship, whilst on the port side (right) the remaining shell plating quickly reduces in height to meet the thicker tapered vertical armour belt plates.

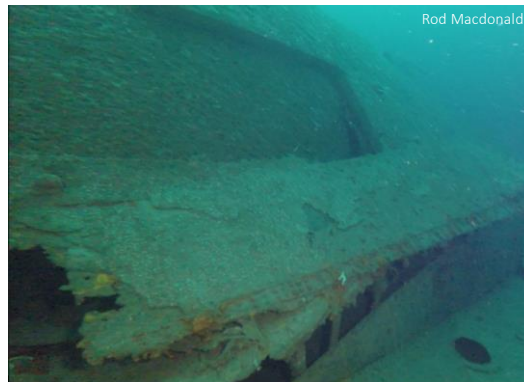
- Further aft on the port side just aft of P-turret, armour belt plates are displaced. Moving further aft, hull plating from the Upper Deck becomes visible as the ship is propped up on her port side by the P-turret and the Bridge structure. This thinner plating has buckled and been pushed out to the side.

*Figure 41: Armour belt and Upper Deck plating at P-turret*

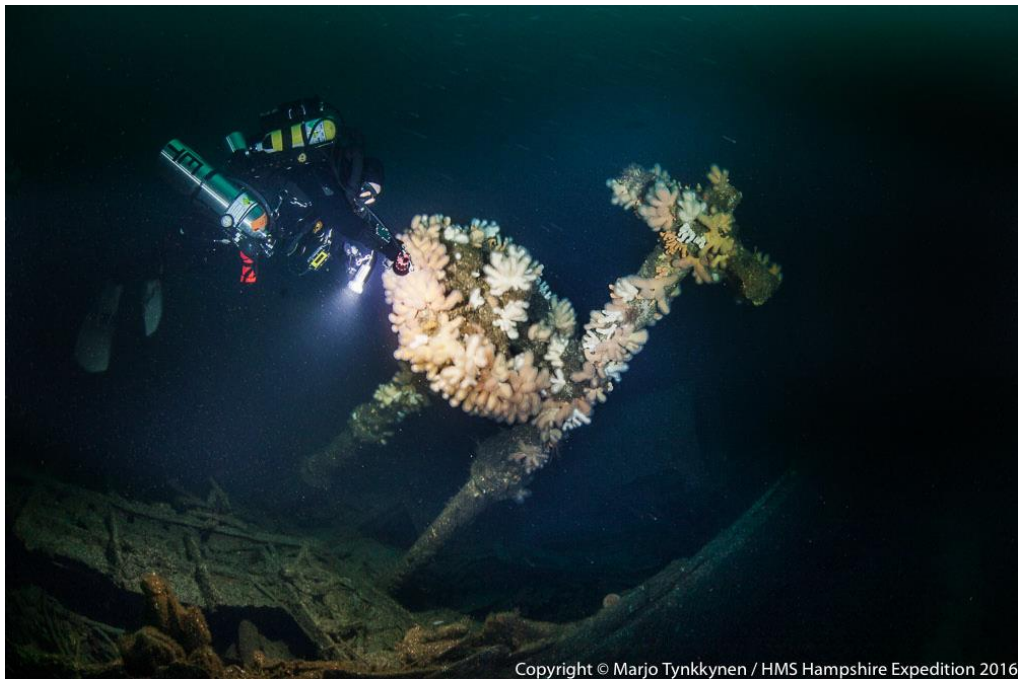
The three anchor capstan drive shafts are undamaged by any blast effect and are canted over to starboard. The deck capstans themselves are under the wreck, with one visible on the port side. The gears seen in the image below would have been driven by a small steam engine, which is also visible in the debris (not pictured).

*Figure 45: Capstan drive shafts*

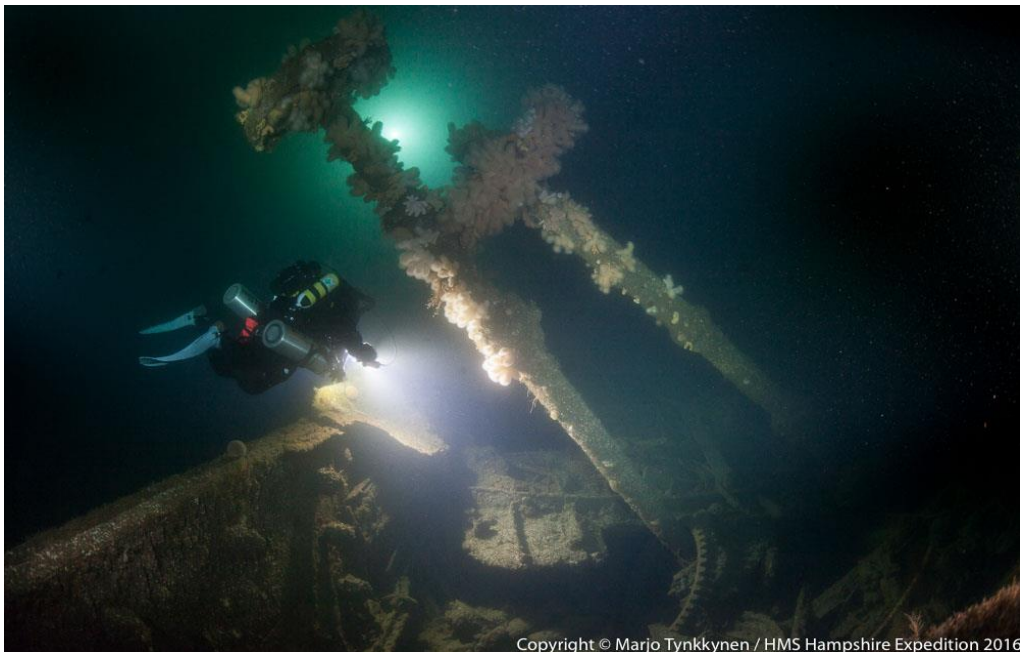
*Figure 46: Forward anchor capstan gears and drive shafts protrude up from the bow wreckage*

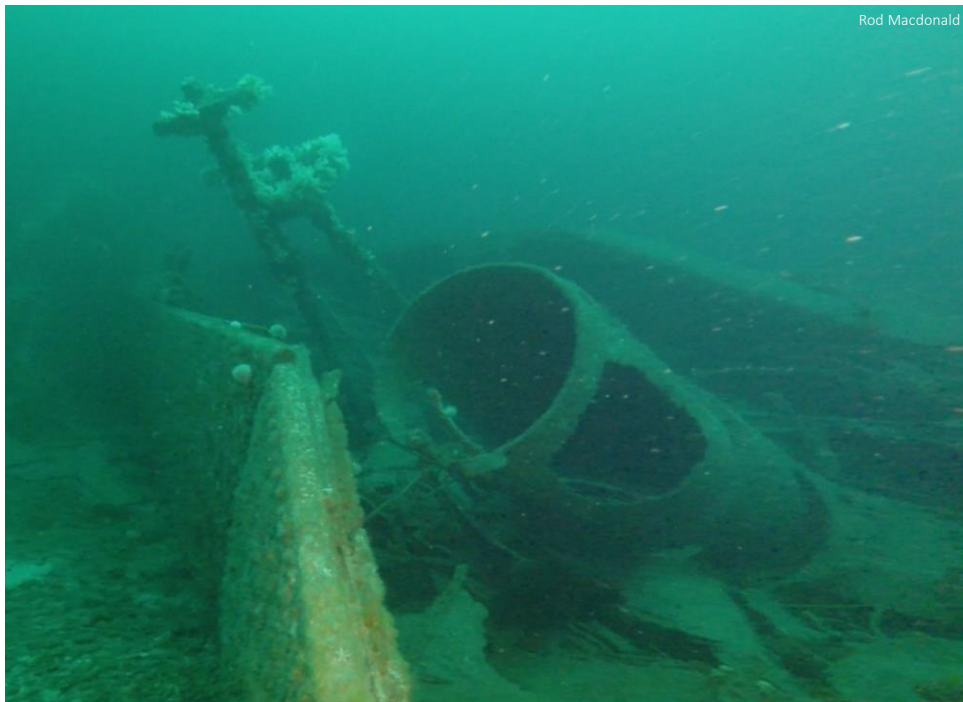
A-turret ammunition hoist trunking lies in the bow debris just aft of the three capstan shafts and leans to starboard. It is still attached to the gun, which is displaced to port and just visible on the seabed. The trunking shows signs of decay consistent with 100 years of submersion in saltwater, but is otherwise undamaged.

*Figure 47: Starboard waterline vertical armour belt plates to left of shot, with A-turret ammunition hoist trunking in foreground and capstan drive shafts and gearing beyond*

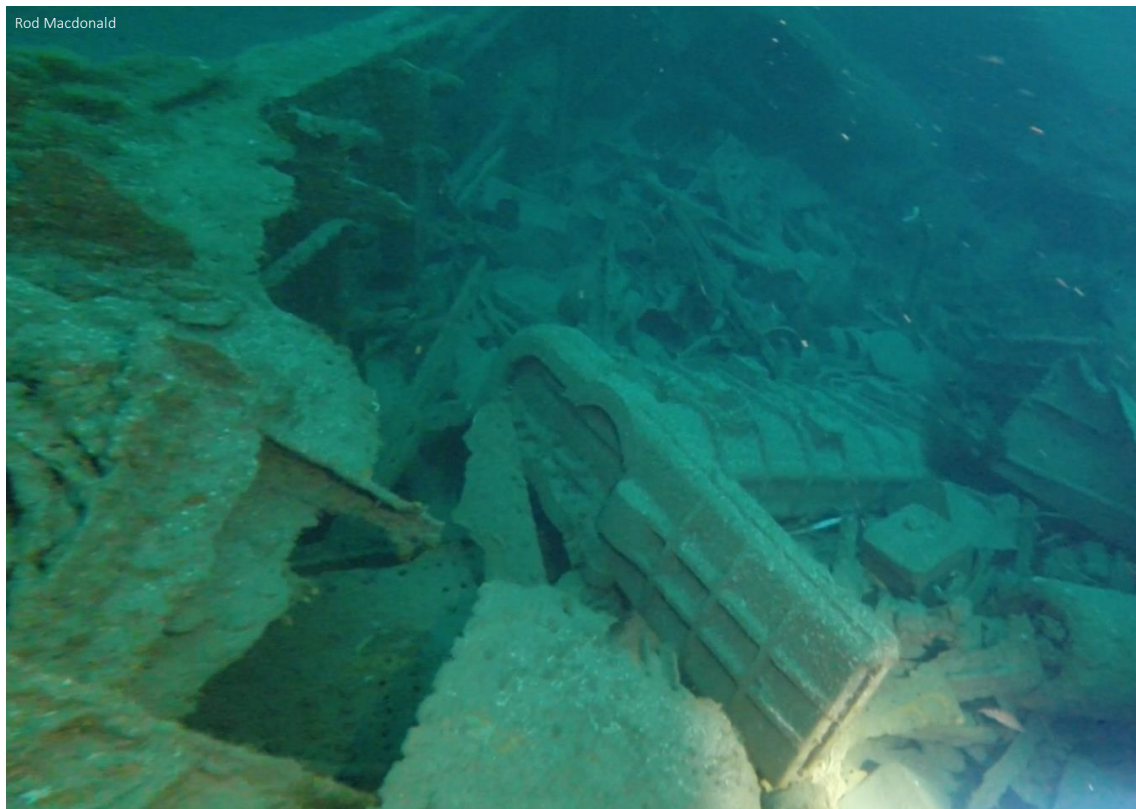
HMS HAMPSHIRE's two lateral submerged torpedo tubes were positioned on the Platform Deck between frame Nos 33 and 37. The starboard torpedo tube lies in the damaged area of the bow in the approximate correct longitudinal position, although it now rests lower in the wreckage. The tube appears complete and undamaged with the inner torpedo door attached. On the seabed the outer door is visible in severed hull plating to starboard. The port side tube was not located during the survey. The port side tube outer door, however, remains in situ in the port hull plating. Intact torpedo warheads lie in the bow wreckage adjacent to the tube and a possible torpedo body lies outside the wreck, flush with the starboard side of the hull.

*Figure 49: Looking forward towards the bow, the starboard torpedo tube can be seen in the debris*

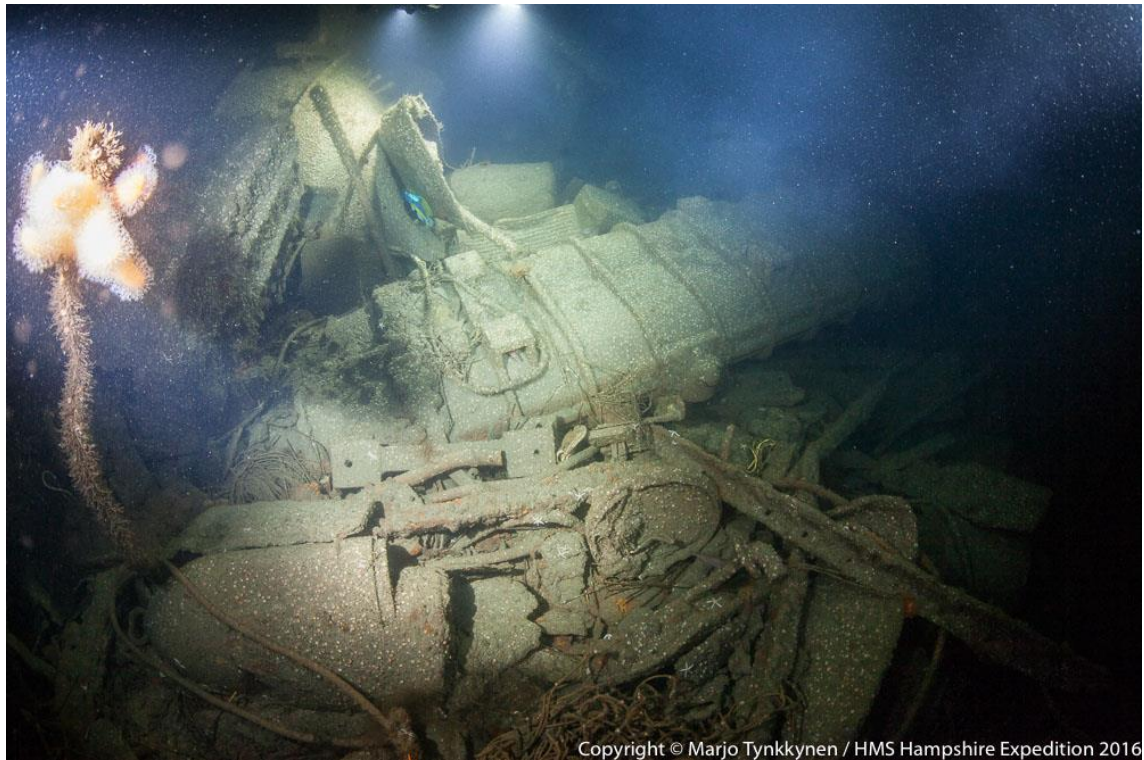
Figure 50: The starboard torpedo tube seen from forward

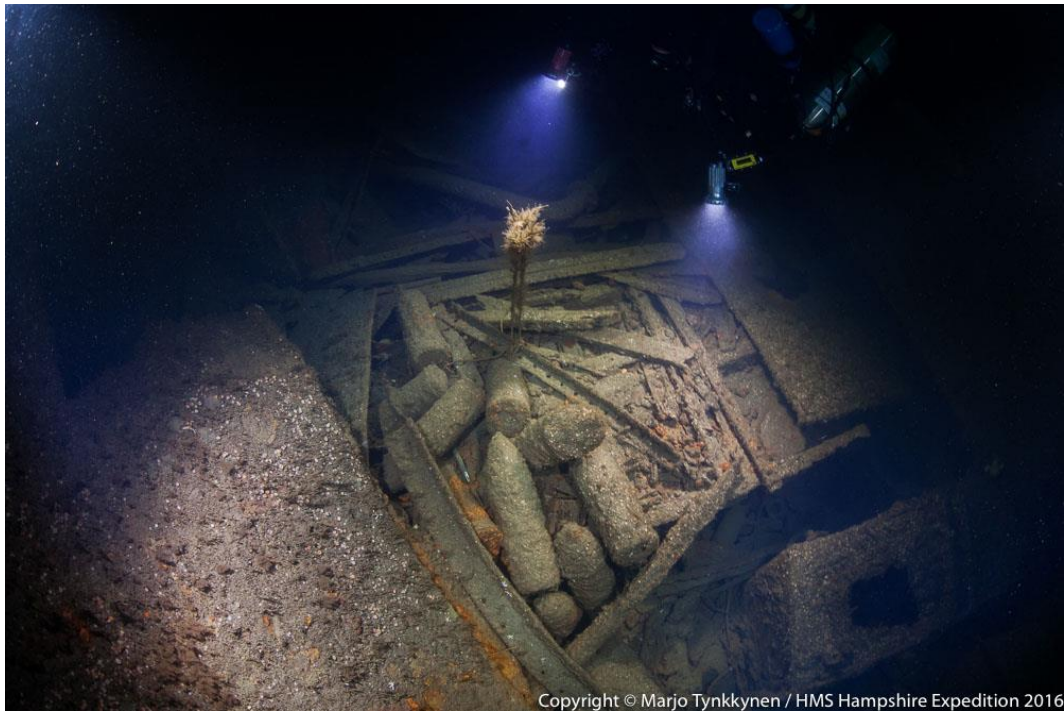
The forward torpedo rooms were surrounded fore and aft by 7.5-inch propellant magazines and shell rooms. The Hold and Platform Decks have collapsed on top of each other down to the armoured Lower Deck, which rest at the bottom of the damaged bow area. Debris from the hull, magazines, shell rooms, torpedo rooms and other compartments now lie amongst the wreckage in this area roughly in their correct relative positions when compared with the plans. Torpedo warheads and sea mines are present along with cordite and cartridge storage boxes and shells. These all appear to be visibly intact, although there is evidence of hydrostatic pressure damage to many of the cordite boxes. The survey found no evidence of explosive damage to the cordite boxes or evidence of mass explosion to any of the other munitions.

*Figure 52: 7.5-inch shells from the remains of P-turret shell room*

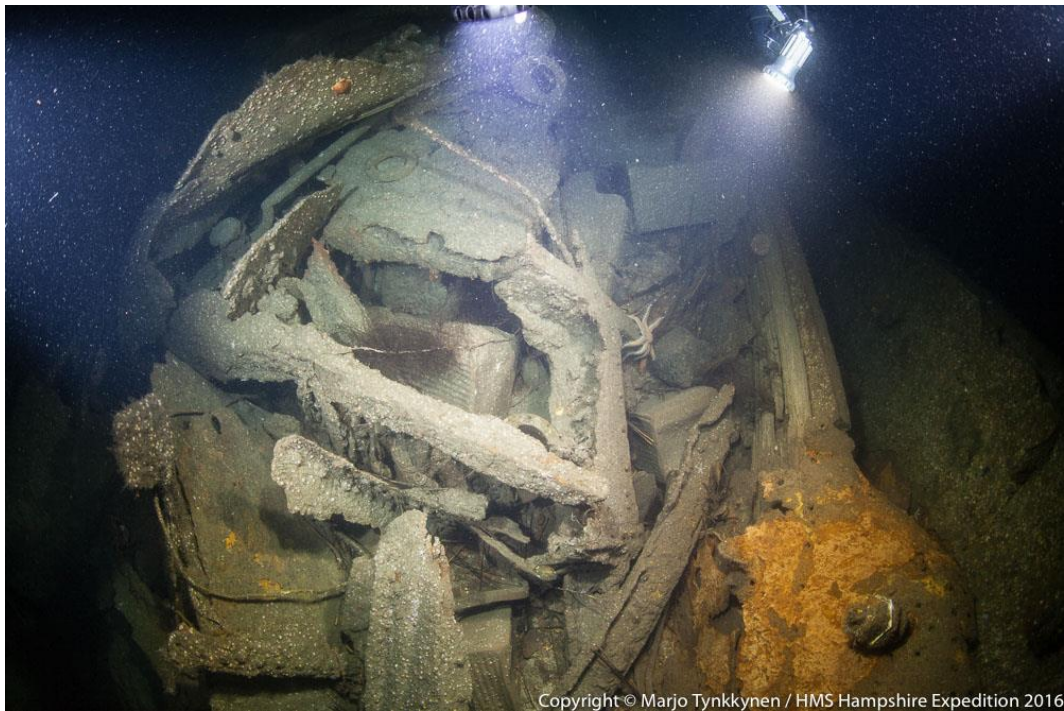
*Figure 53: Cordite in ribbed brass flash-proof storage boxes lie in the bow wreckage adjacent to internal timber support for the armoured belt. Note the large stud nut in bottom right*

Close to A-turret hoist trunking, 7.5-inch cordite can be found in ribbed brass flash-proof storage boxes from the propellant magazine. Internal timber support strips for the armour belt (to right of Figure 53, above) designed to cushion the shock of large calibre hits on the

armour belt to protect the inner ship are also visible. A large stud nut (to bottom right of image) secures the bolt that goes through the inner ship's side and is tapped into the back of the armour belt plating.

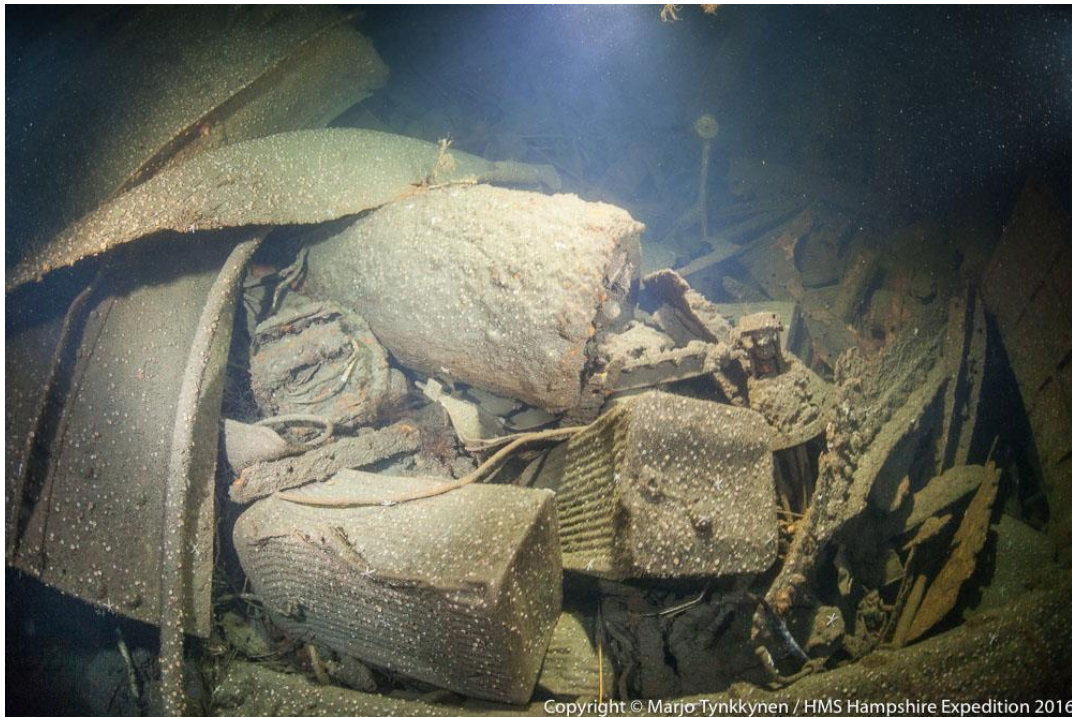
*Figure 54: 7.5-inch flash-proof ribbed brass cordite storage boxes in vicinity of P & Q-turret magazine*

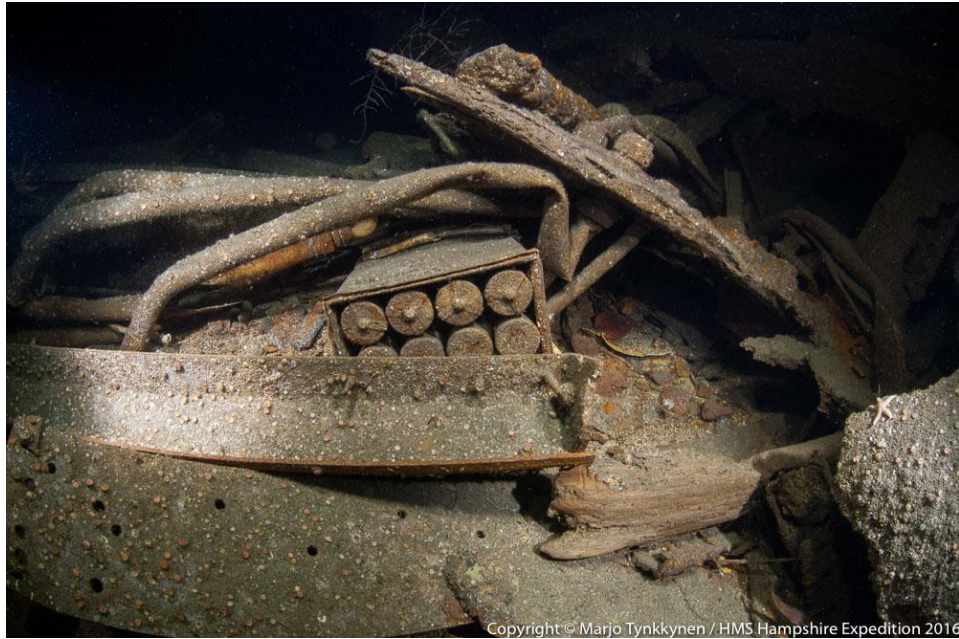
*Figure 55: Box of 12 per QF brass cartridge cases containing cordite*

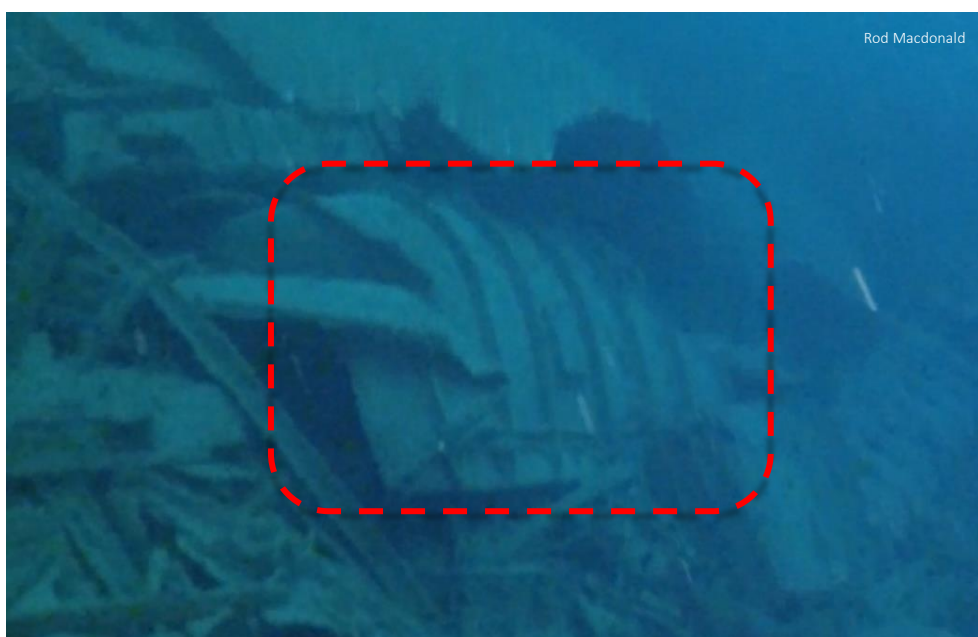
The Lower Conning Tower was a secondary control position located below the Bridge on the Platform Deck. It housed all necessary equipment to control the ship, including steering helm, compasses and telegraphs. To aid in reducing magnetic interference the walls of the room were made of brass with a solid brass transverse bulkhead forwards. This entire bulkhead is located at frame No 37 and lies athwartships in the bow area debris just forward from where the hull begins to resume its original shape at frame No 38. The bulkhead is uniformly curved inwards aft, consistent with the effects of a powerful explosion close by.

Figure 58: Buckled transverse bulkhead

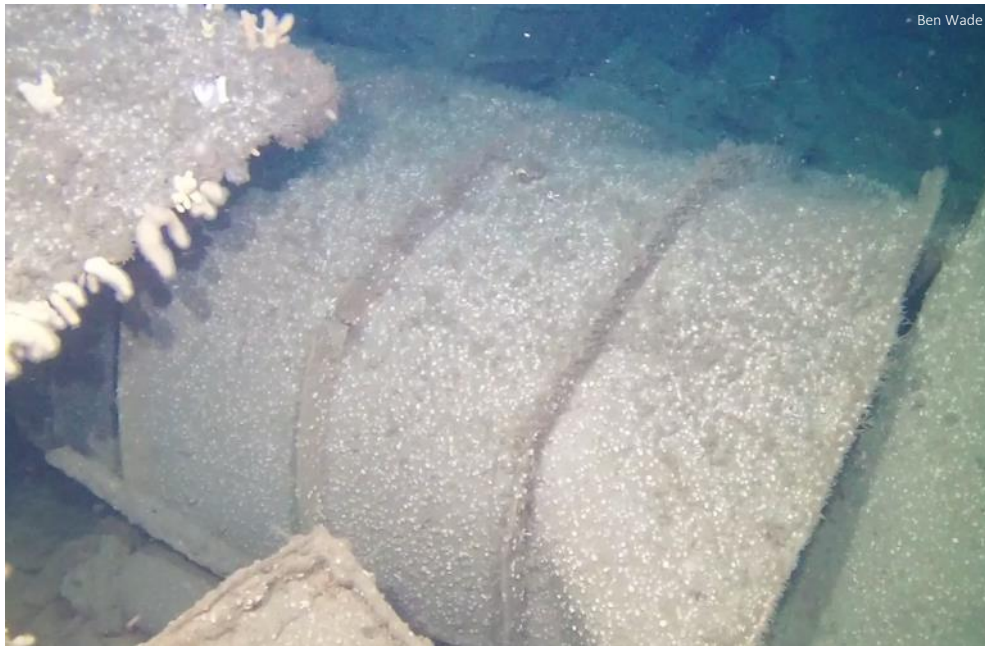
*Figure 59: Lower Control Room brass transverse bulkhead looking forwards*

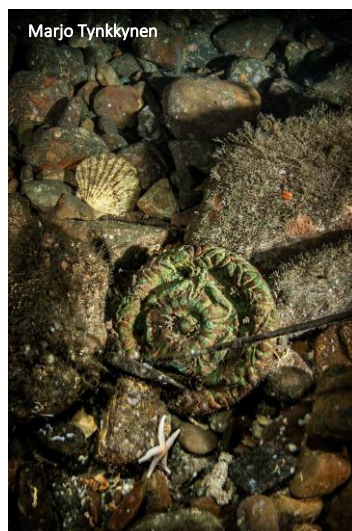
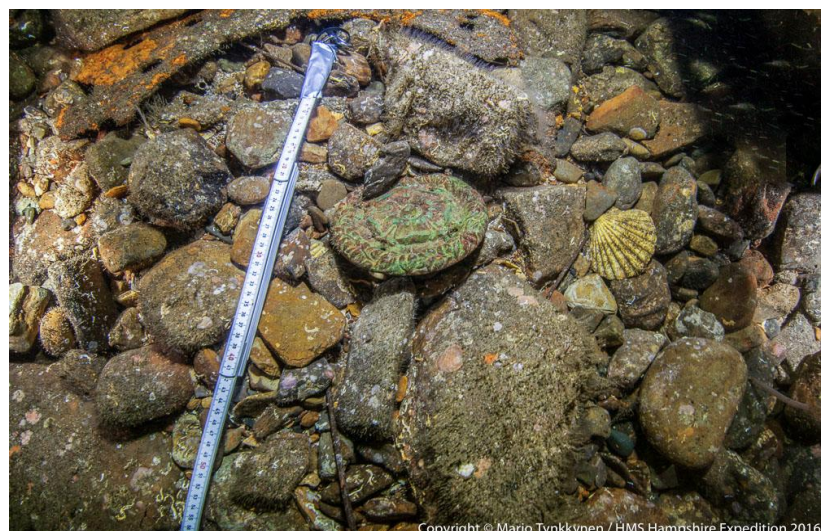
Lying on the seabed a few metres away from her stem is a small nonferrous artefact (likely bronze) some 7 – 7.5 inches across. This is believed to be a decorative tampion cover for one of her main 7.5-inch gun barrels. The artefact's location makes it highly likely that it is from A-turret. The historic emblem of the county of Hampshire, a rose surrounded by a crown of leaves, can still be clearly seen. There are 4 screw holes in the face of the tampion plate where the plate was affixed to a wooden tampion body that fitted in the end of the barrel.

*Figure 60: Forward 7.5-inch tampion plate lying on the seabed near the bow.*

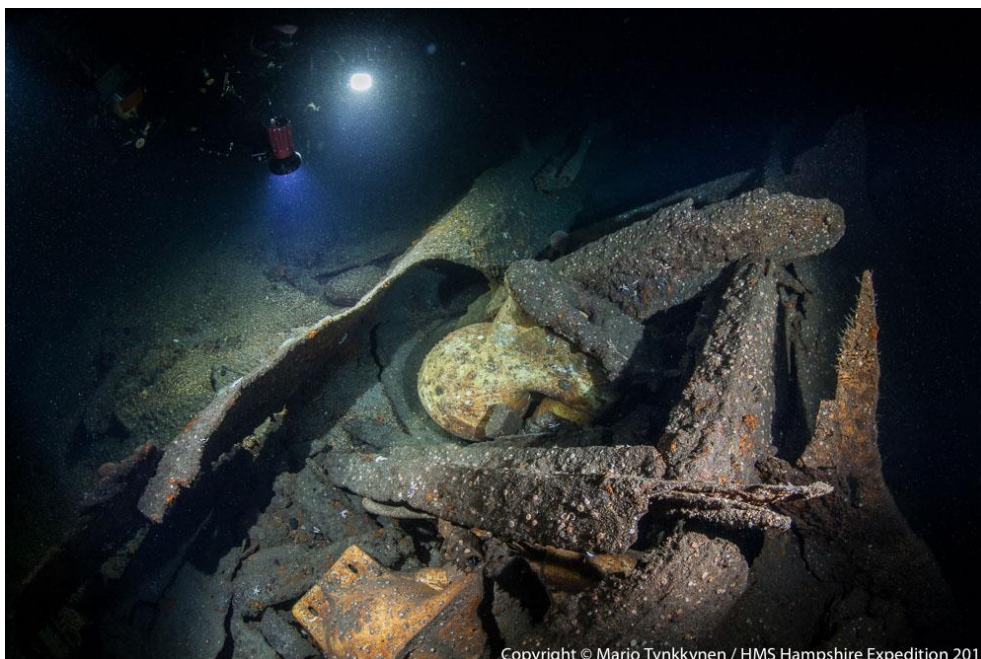
Figure 62: The white toilet and wash hand basin from the sick bay lie upside down in the bow debris

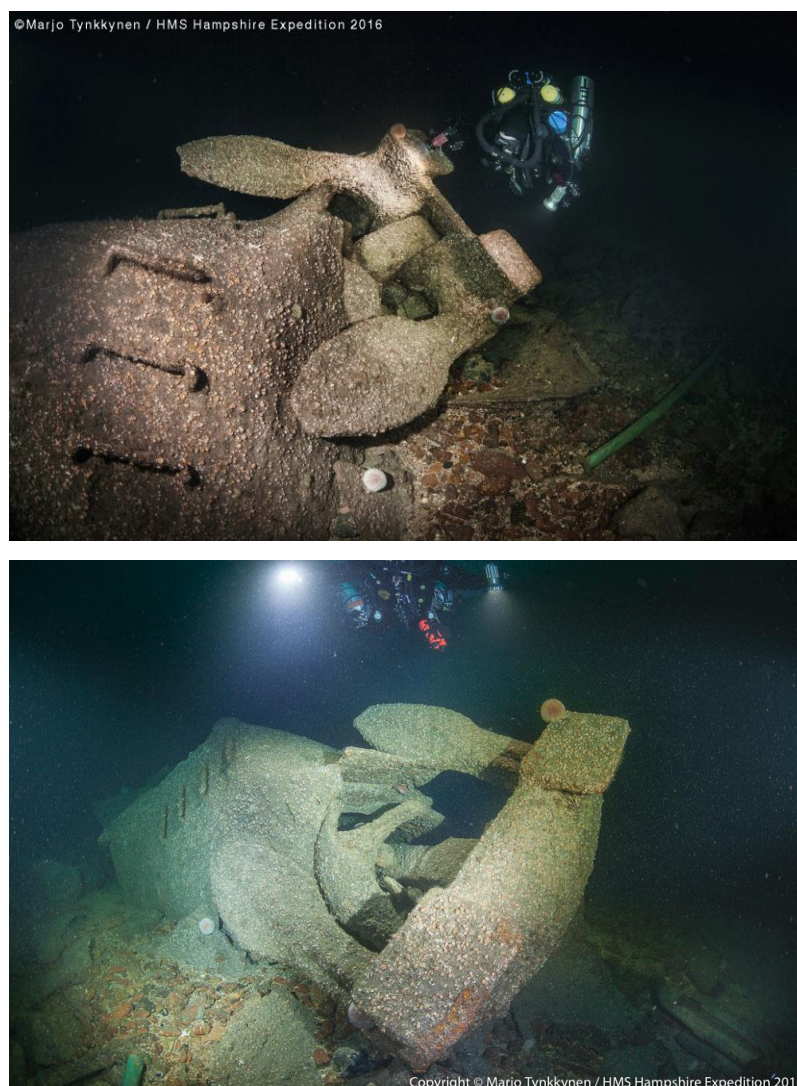
HMS HAMPSHIRE, as with many Royal Navy vessels, was fitted with two bower anchors, one on either side of the bow and a third sheet, or emergency anchor, on the starboard side abaft the bower anchor. The port bower anchor lies on the seabed on the port side of the wreck, still secured in its hawse in a detached section of hull plating. The hull plating has been pushed out to port as the ship came to rest upside down on the seabed. Fixed ladder rungs run up the shell plating alongside. There was no sighting of the two starboard anchors, which are presumed to be buried under the wreck.

*Figure 63: Displaced port side anchor in hawser*

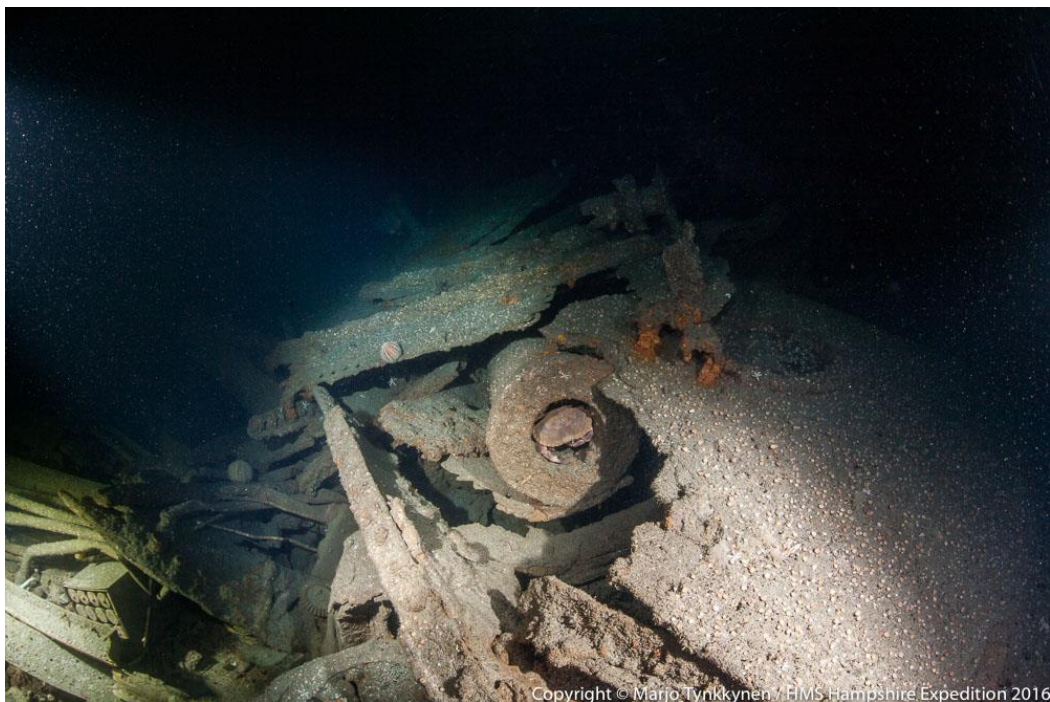
Aft of the anchor on the port side seabed A-turret gun house is visible under the wreckage having been displaced to port during the sinking. P-turret is in situ and clearly visible with the barrel running parallel to the remains of the hull.

*Figure 65: The port 7.5-inch P-turret gun barrel abreast the bridge projects from debris*

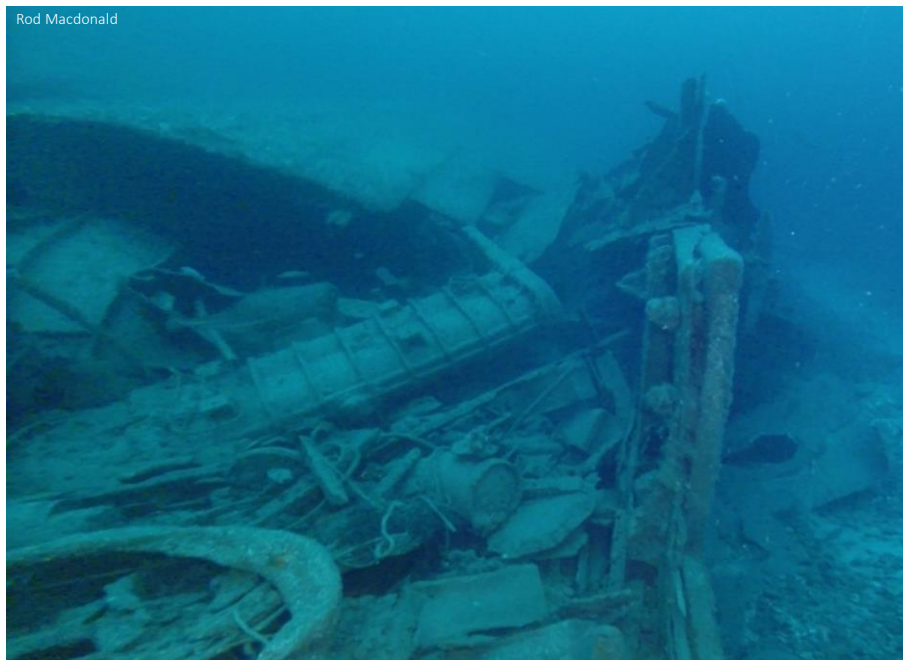
*Figure 66: Starboard broadside torpedo tube, located in the bow debris*

Looking aft (Figure 66) from the bow along the starboard side of the ship reveals how the keel frames, stringers and shell plating of the bottom of the hull are missing. The keel reforms aft of the ribbed starboard submerged torpedo tube. The starboard ship's side is seen to right of shot with the exterior torpedo tube door lying on the seabed. The large bolts and nuts holding armour plate to the hull are seen on the inside face of the closest starboard plate.

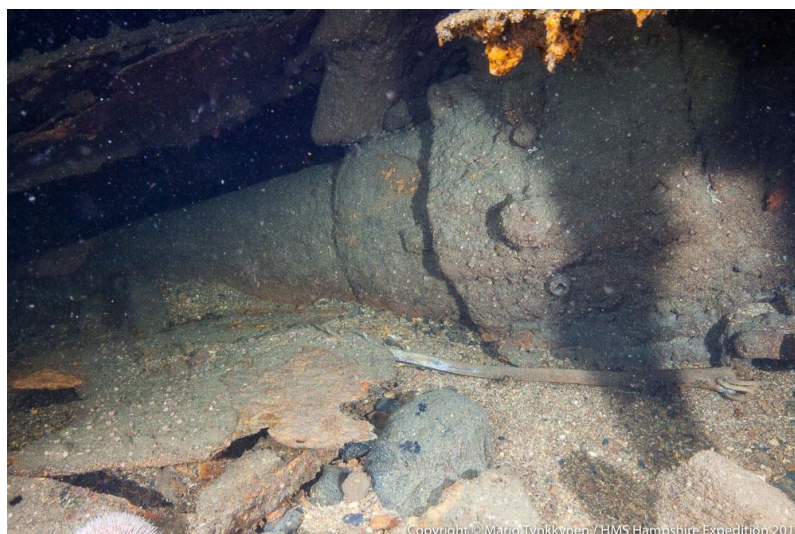
*Figure 72: The 4th Mk VII 6-inch gun barrel lies under the wreck*

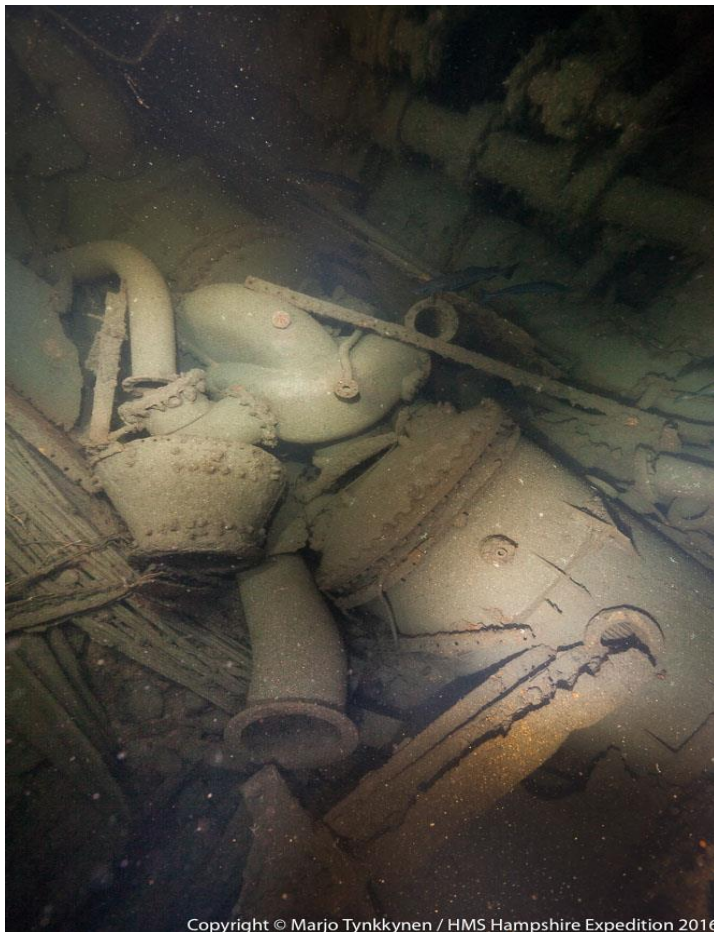
*Figure 77: Port side engine room condenser viewed from the top of the port side fissure*

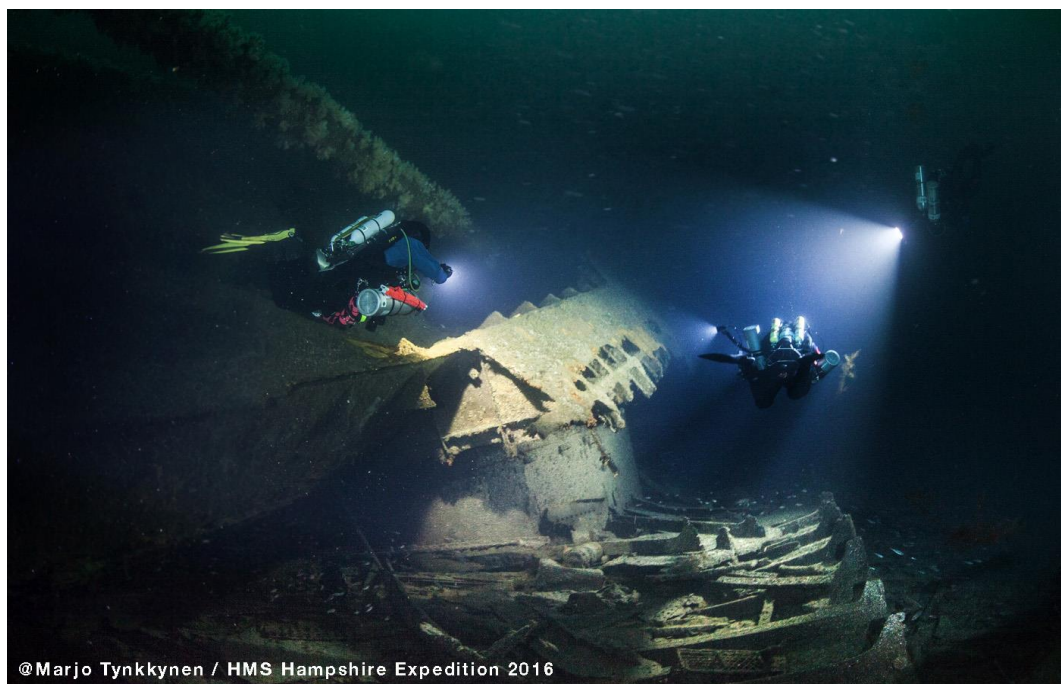
The stern section is propped up on her port side supported by Y-turret. The majority of the hull plating for the Main Deck and the Lower Deck has corroded away from the aft casemate to the stern leaving a substantial gap under the ship. Surviving hull material from this area lies face down on the seabed. Y-turret 7.5-inch gun barrel cannot be seen and appears to be swung to starboard – the direction of capsizing – and is now buried in the seabed under the wreck.

Figure 85: The back of Y-turret gunhouse seen from astern with the free section of the port prop shaft above. The barrel appears to be swung to starboard in the direction of her capsizing

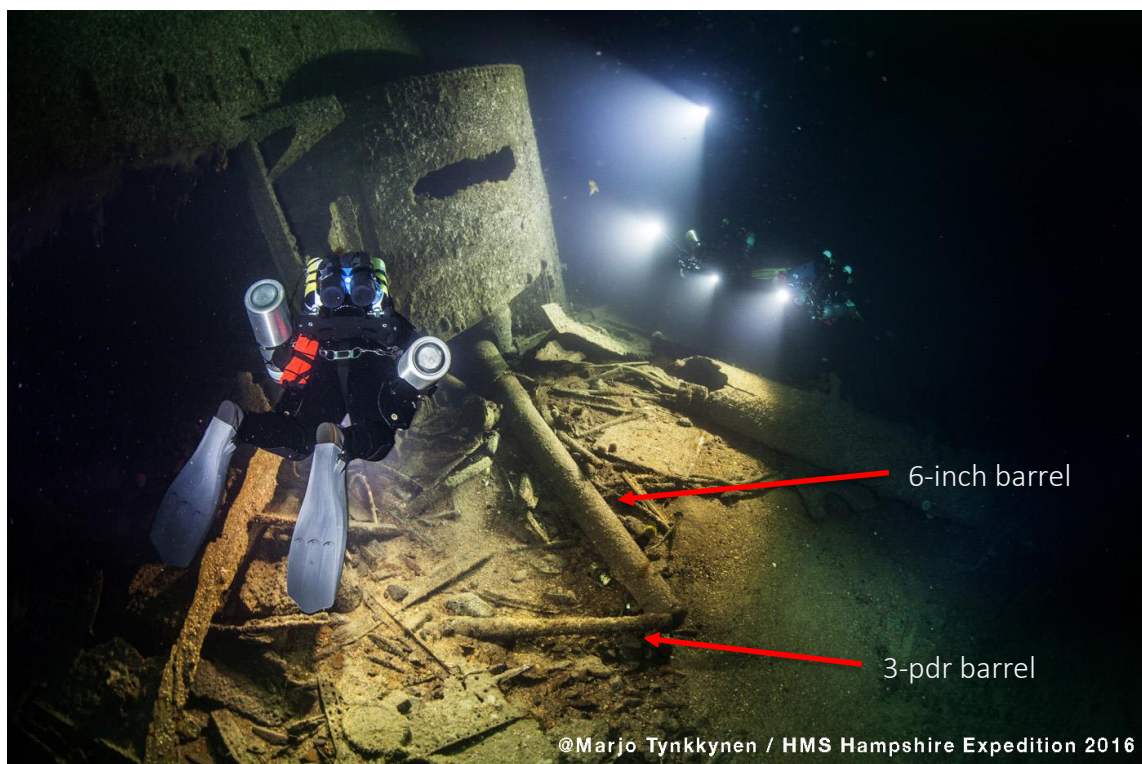
The lower of each of the two super-firing aftmost 6-inch casemate guns, X3 & Y3, were demounted in 1916 and moved to the Upper Deck in place of demounted 3-pdr QF guns. The lower casemate firing ports were then plated over to improve seakeeping. This plate can still be clearly seen on the port side – the plate has rotted through in the middle.

The aft port side casemate sits in situ and mostly intact except for parts of the casemate armour plate which has become detached from the main hull structure at the forward edge. Parts also lie on the seabed. The higher (now lower) Y1 6-inch gun barrel projects outwards and astern - its barrel lying flat on the seabed.

*Figure 90: The superfiring Y1 6-inch gun barrel projects from the (now lower) firing port. The plated off lower 6-inch gun Y3 firing port can be seen above – its plate rusted through horizontally. The barrel of a buried QF 3-pdr rises up from the left to meet it*

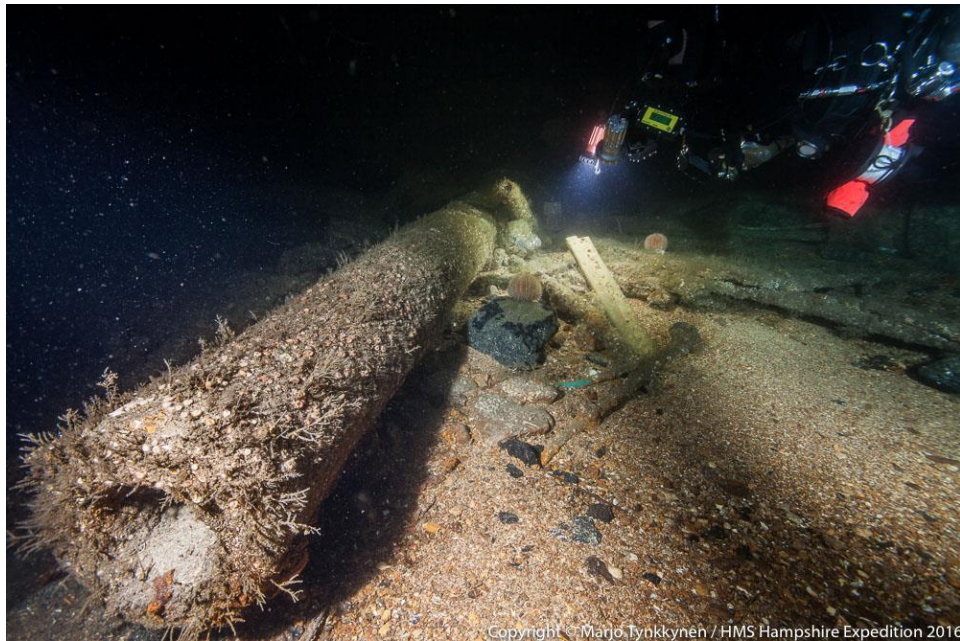
Figure 91: The upper 6-inch Y1 casemate gun barrel lies flat on the seabed pointing aft

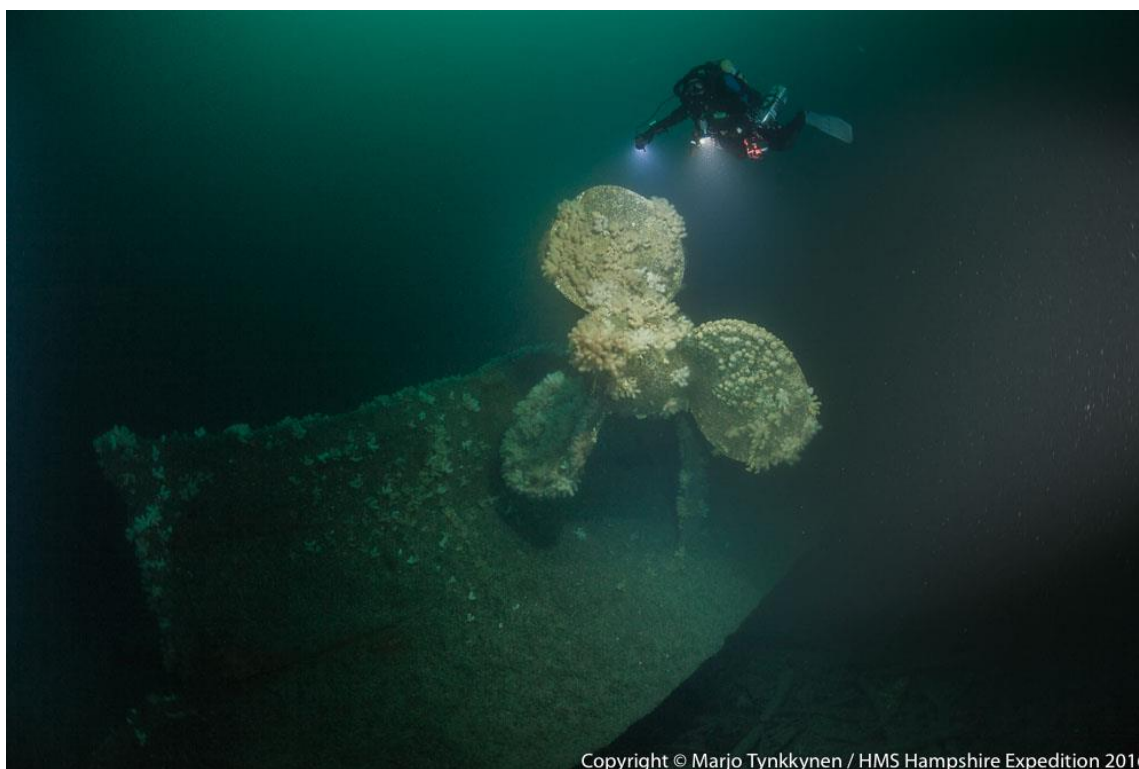
The manganese bronze port propeller, A-frame bracket and shaft are still present on the wreck. The shaft is slightly bent towards the seabed where it exits the ship due to the distortions in the wreck around Y-turret.

Figure 93: Port side propeller

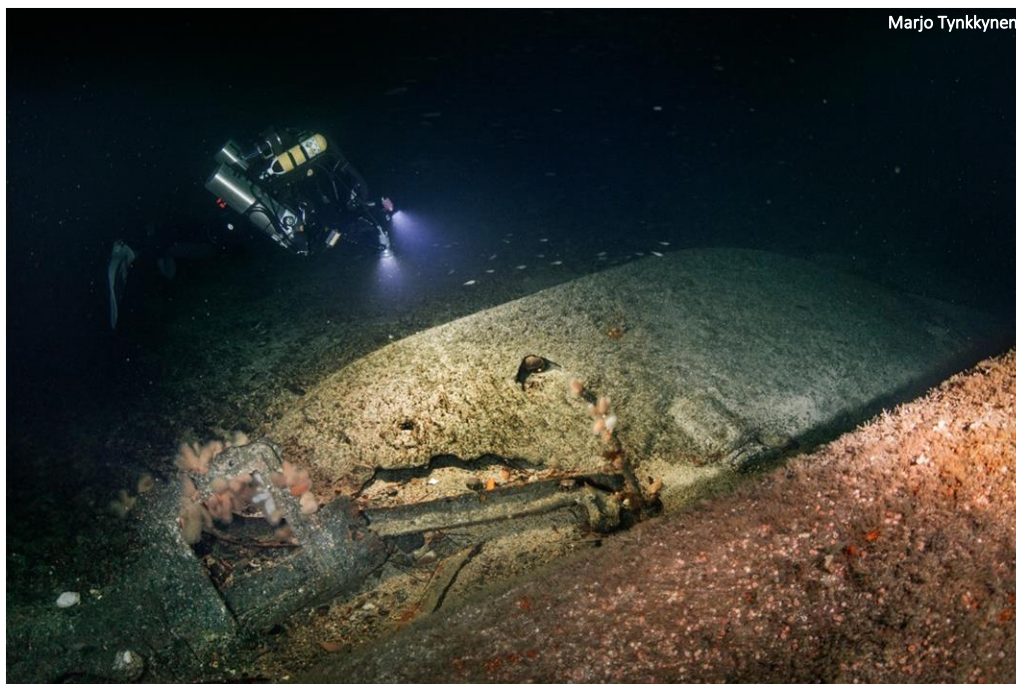
The rudder has fallen from its mount to lie flat on the seabed to starboard (Figure 95, below).

*Figure 95: HMS HAMPSHIRE's rudder*

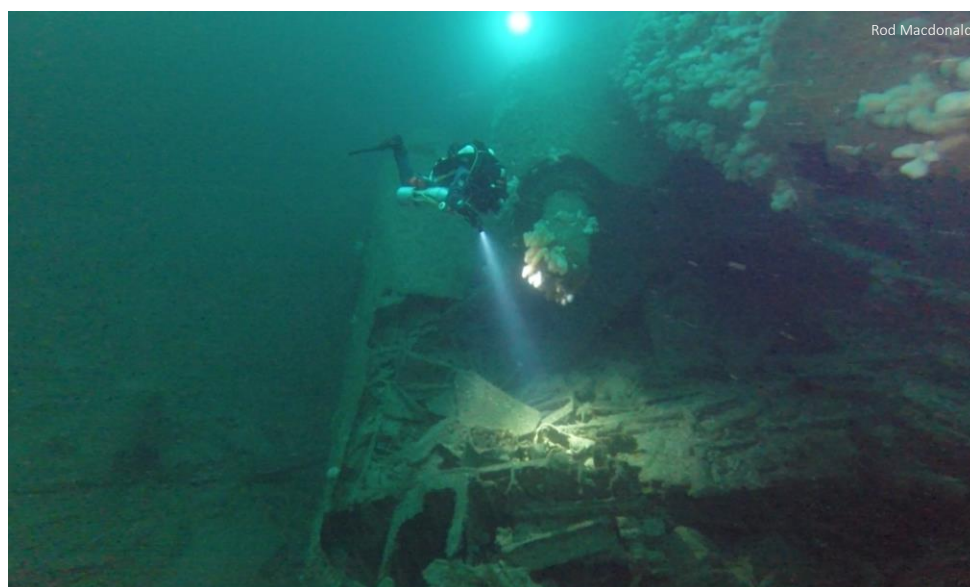
The starboard propeller is not present on the wreck. It was recovered in 1983 during a survey and is now on display at the Scapa Flow Visitor Centre & Museum on the island of Hoy. All that remains of the starboard side stern gear is the severed end of the shaft. The starboard shaft emerges from its stern tube in the photograph below (Figure 96) and appears to have snapped at this point.

*Figure 96: Severed starboard side prop shaft*

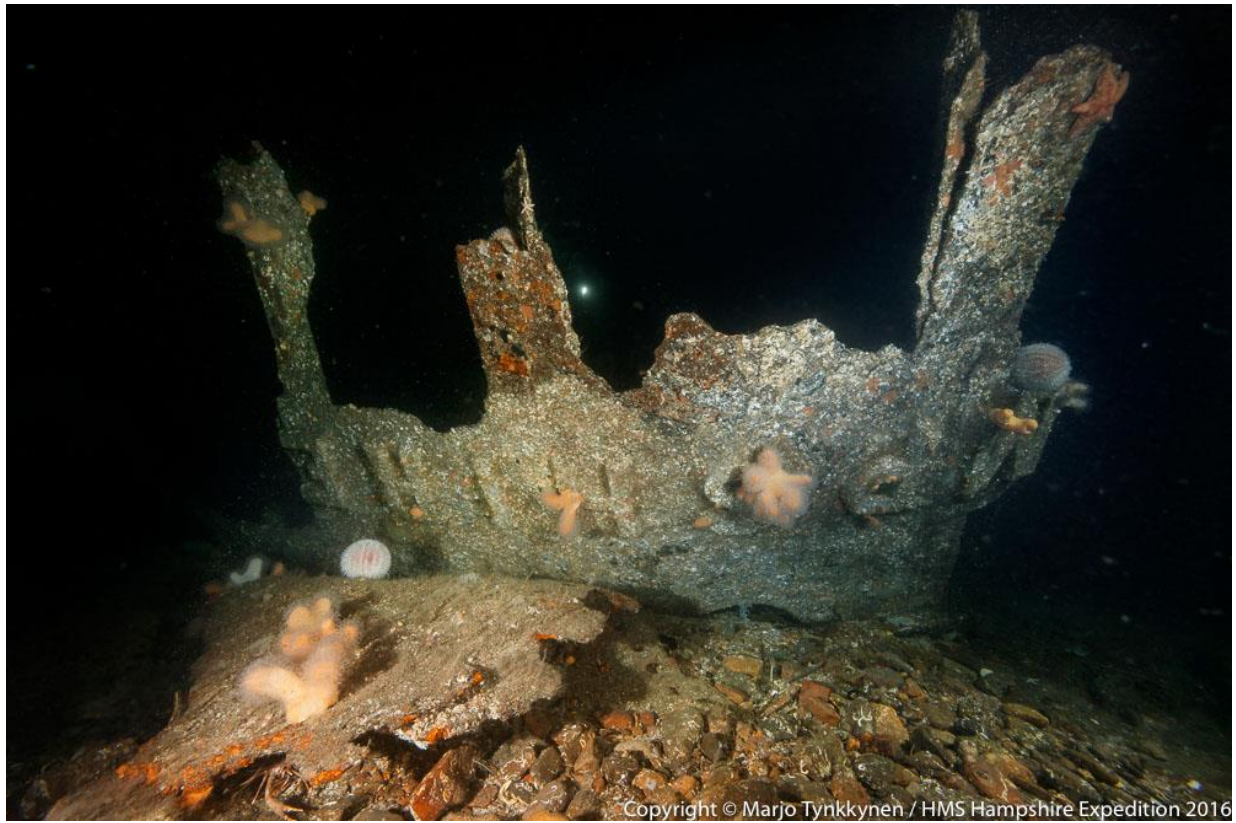
Of the stern of HMS HAMPSHIRE, the keel to the the Platform Deck remains intact. The aft part of the ship now rests on her armoured deck and the Lower and Main Decks are absent, except for a small part of the Main Deck at the very stern which now sits separated from the main stern wreckage by aproximately two metres. This wreckage contains the sternmost porthole from the Main Deck and the remains of the ship's name. Hull plating from the Lower and Main Decks now rests on the seabed to port and starboard.

*Figure 98: The remains of HMS HAMPSHIRE's name can be clearly seen*

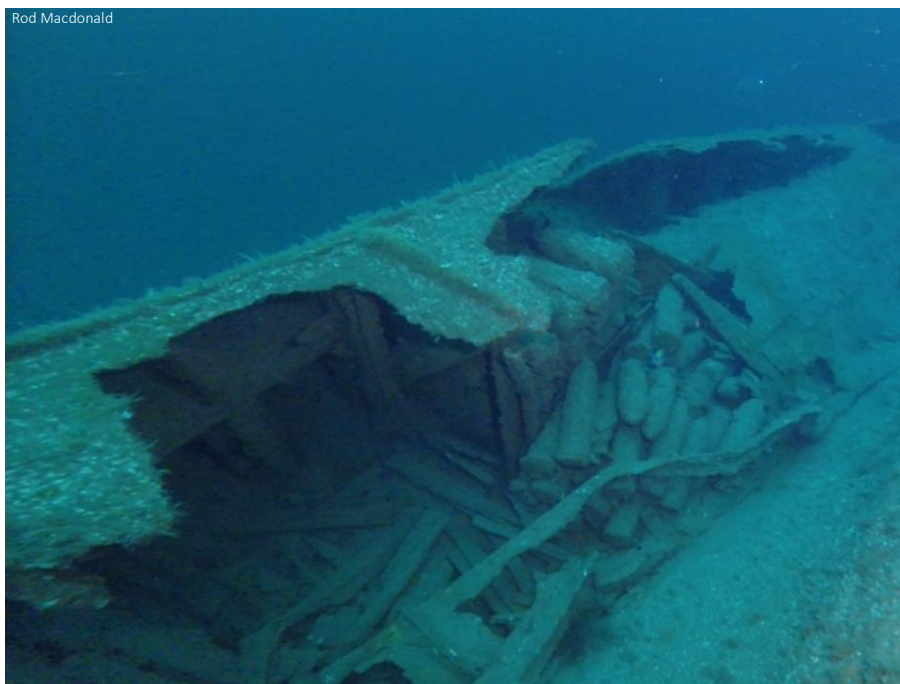
*Figure 102: A view from forward, looking aft of the port 6-inch shell room showing separation and collapse of hull bottom (right) from port side of the ship (left)*

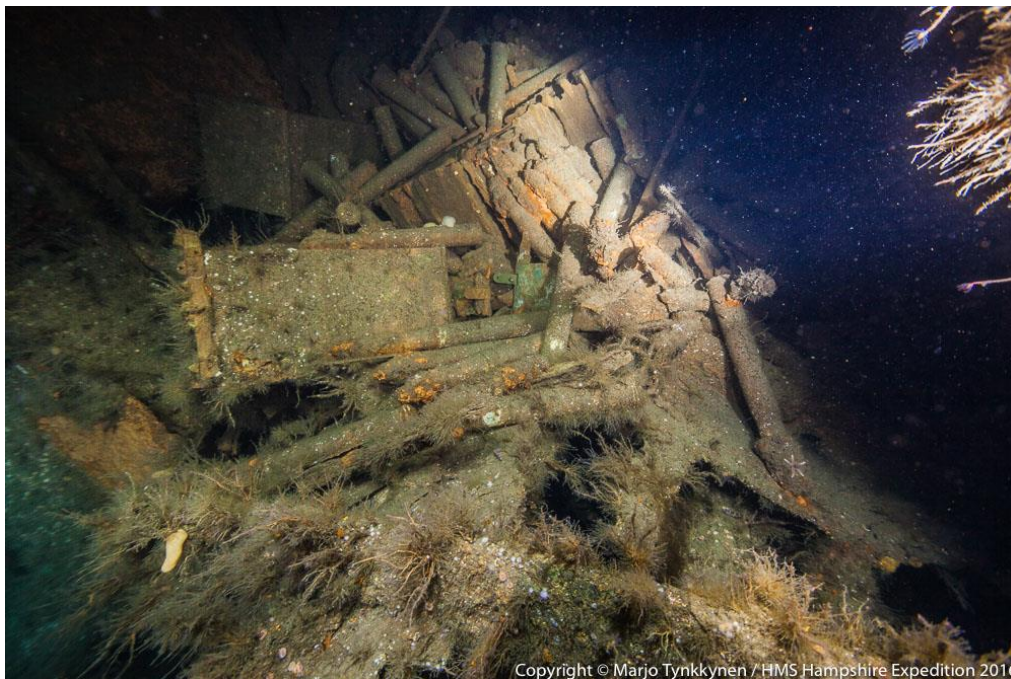
Collapsing of the hull underneath the free section of port prop shaft in the vicinity of Y-turret has exposed the 3-pdr magazines located in the Hold (see Figure 103).

Dozens of rounds of 3-pdr Vickers Mk1 QF fixed ammunition are present, each comprising of a brass cartridge containing cordite, and a corroded steel projectile containing fuze and explosive. Each round of ammunition is approximately 0.5m long and 5cm diameter.

*Figure 103: Vickers 3-pdr QF ammunition abaft Y-turret, directly under the port prop shaft*
