# HMS HAMPSHIRE 100

Survey Report

## HMS HAMPSHIRE 100 Survey Report

Location:            Atlantic Ocean, waters west of Orkney, Scotland

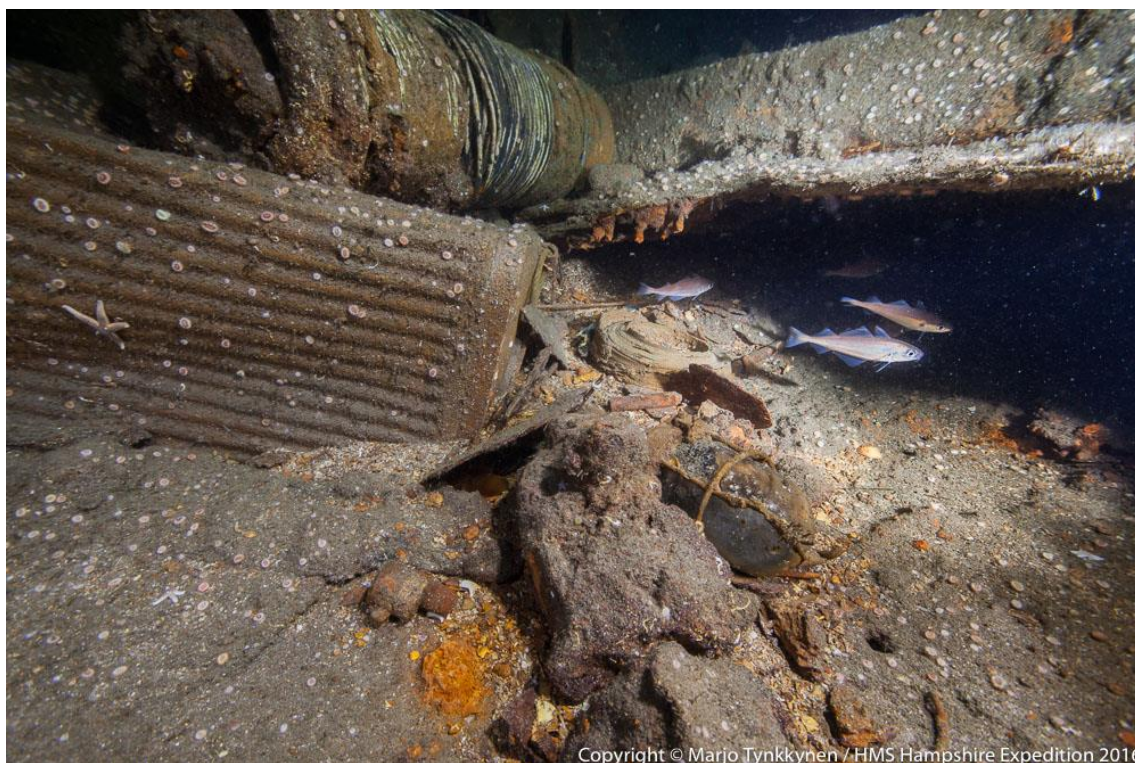
On the seabed in the area are the remains of the 7.5-inch Y-turret magazine. Ribbed flash-proof brass boxes of propellant and scattered cordite are spilled onto the seabed both to port and starboard.

*Figure 104: A brass cordite case. A cage lamp with glass intact lies to its right*

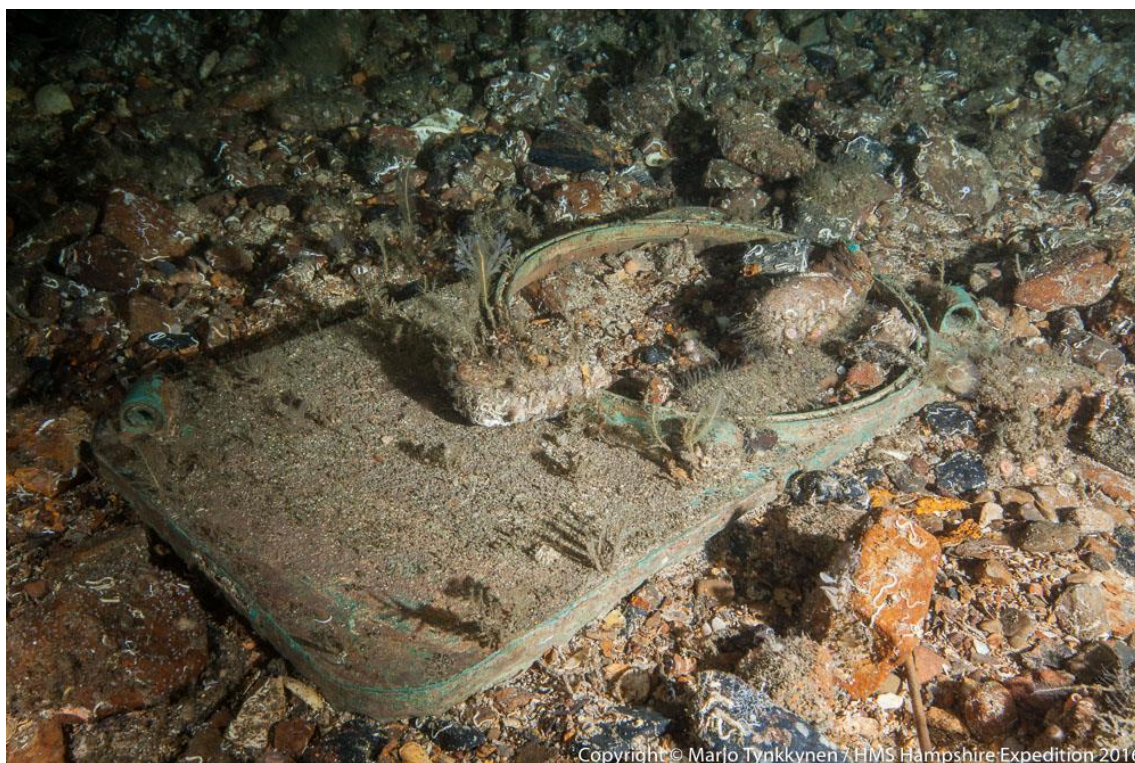
*Figure 106: Cordite box lid on seabed*

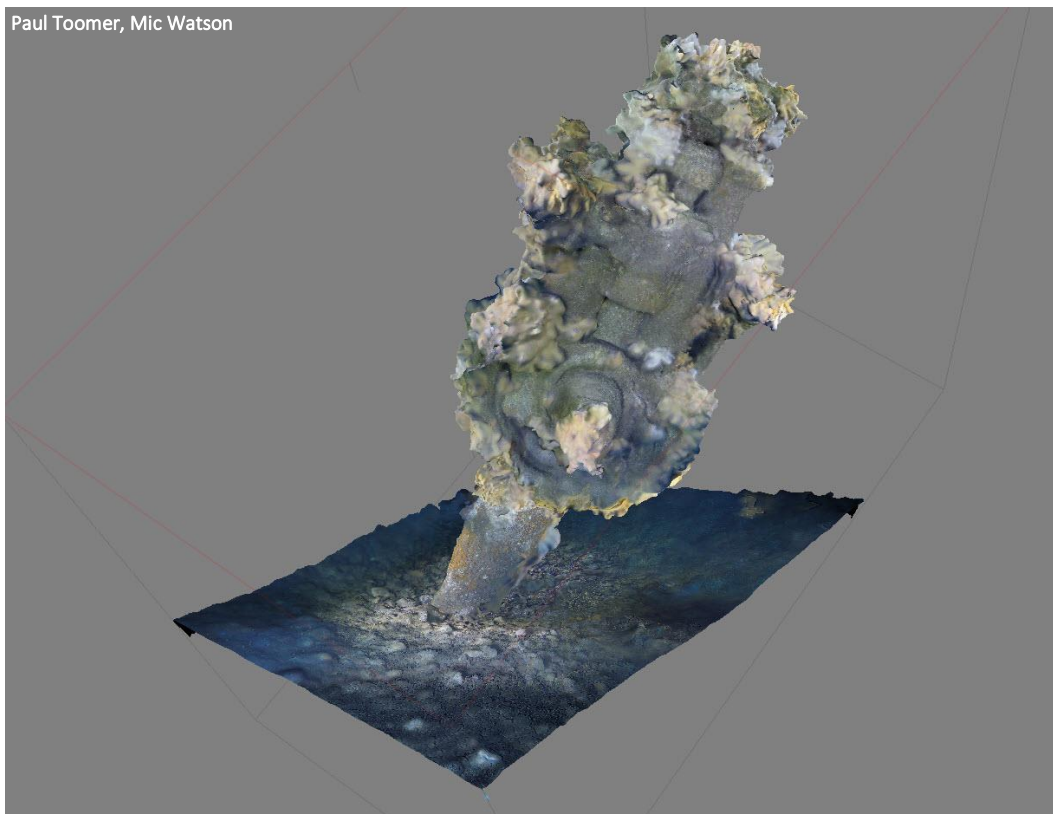
Figure 116: 3D photogrammetry of the 6-inch Vickers Mk VII gun fallen from its mount as the ship capsized. It impaled itself barrel first in the seabed

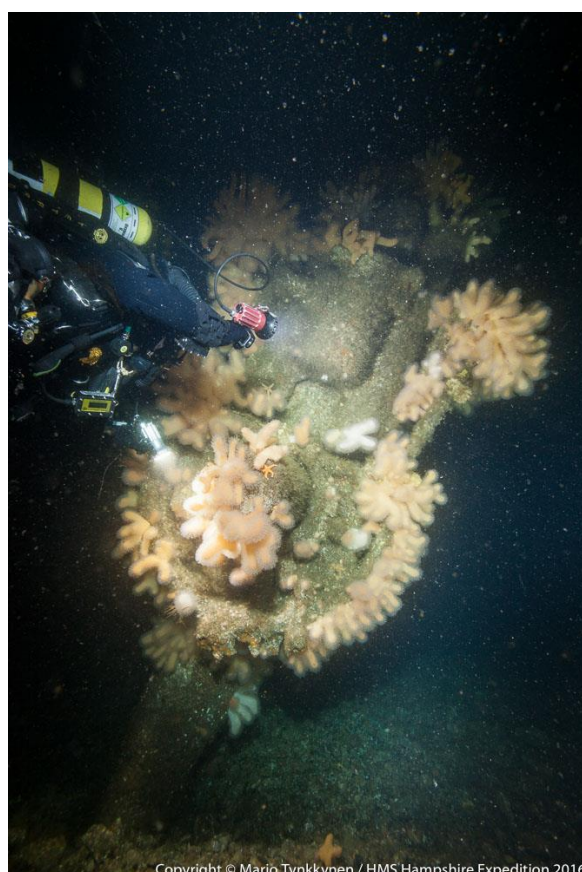
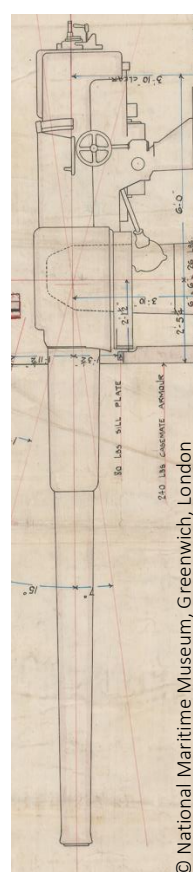
Figure 117: A second Vickers Mk VII 6-inch gun has fallen from its deck mount as the ship capsized. Its barrel has penetrated 4-5 metres into the seabed like a dart. Alongside is a schematic of the Mk VII 6-inch gun

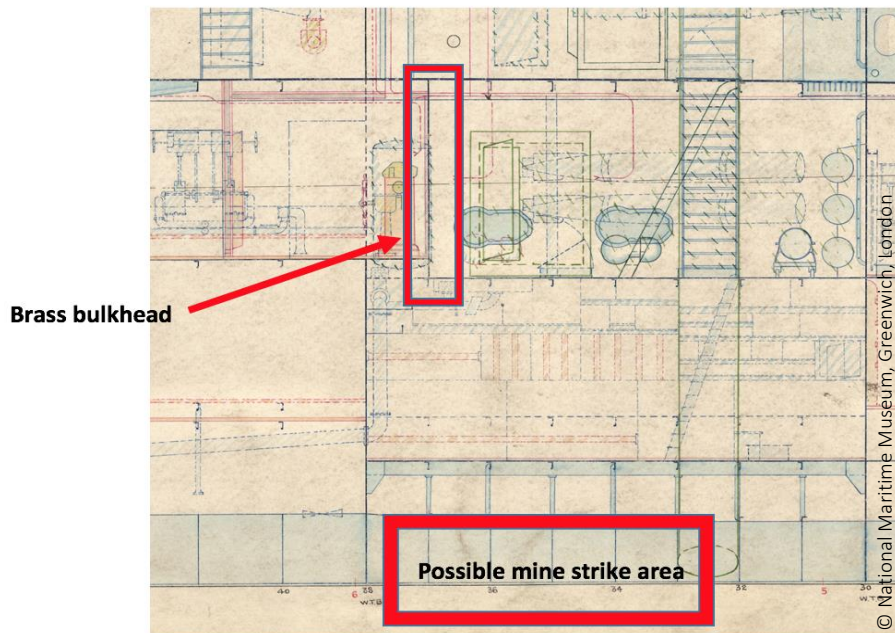
HMS HAMPSHIRE hit the mine in the forward part of the ship as she steamed into the minefield. The only visible signs of blast damage to the ship found during the survey is seen on the forward brass bulkhead of the lower conning tower. This is uniformly bent across its width to almost ninety degrees along its lower edge, suggesting that the explosion from the mine was very close to this position.

*Figure 120: Ship's plan extract detailing position of possible mine strike and location of lower conning tower brass bulkhead*

- The imagery of the torpedo room area clearly shows a brass bulkhead bent through at approximately 90 degrees, with crack damage to the stiffeners consistent with mine damage. The damage to the bulkhead is relatively symmetrical suggesting that the explosion was aligned with it along or close to the central axis of the ship.

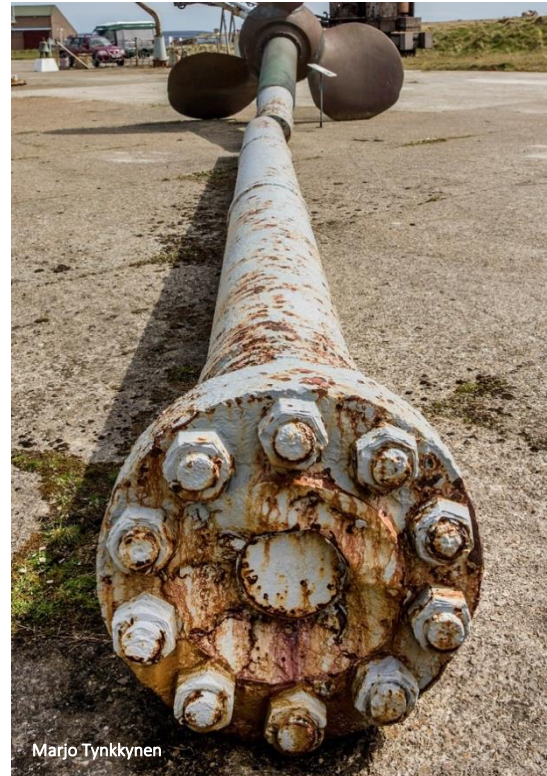
When the starboard propeller was salvaged in 1983 it was reported to have been lying on the seabed and not attached to the wreck. The severed end of the shaft, currently housed at the Scapa Flow Visitor Centre in Hoy, provides evidence that the shaft was snapped, and not cut.

- The fracture surface of the propeller shaft where it is broken from the ship is adjacent to a bolted flange joint.
- There is no sign of blast damage to the bolted joint or flange.
- There is evidence of cup and cone fracture surfaces consistent with a bending fracture mechanism. Essentially, it has bent and snapped either when the ship hit the seabed or subsequently as the ship has decayed, or possibly through illegal, commercial salvage works.
- The current condition of the port propeller shaft on the ship shows signs of stress consistent with the location of the break on the starboard shaft on the ship.

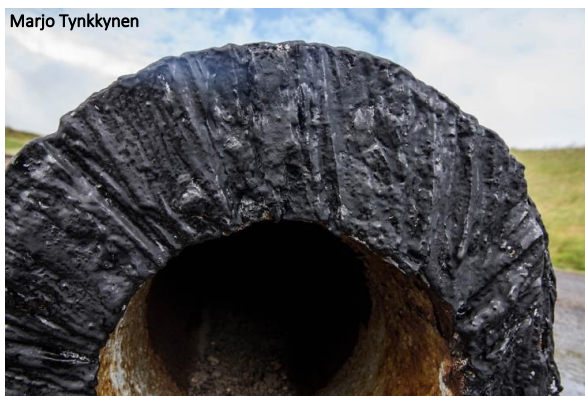
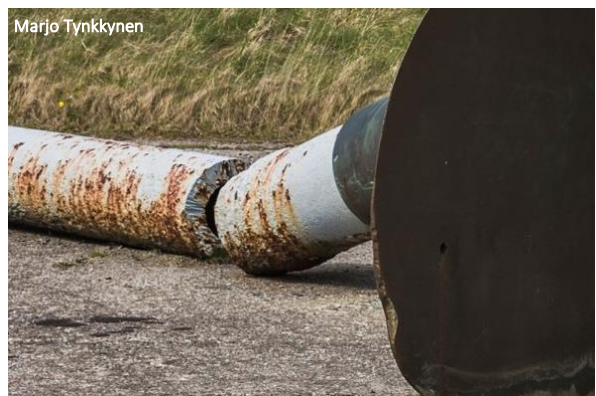
- The starboard shaft has been cut just forward of where the cutlass bearing would have been. This cut has been made post salvage, as archive images of the landed artefact show the shaft and propeller as a composite unit. It is suggested that the cut may have been made in order to ship the items to Lyness.

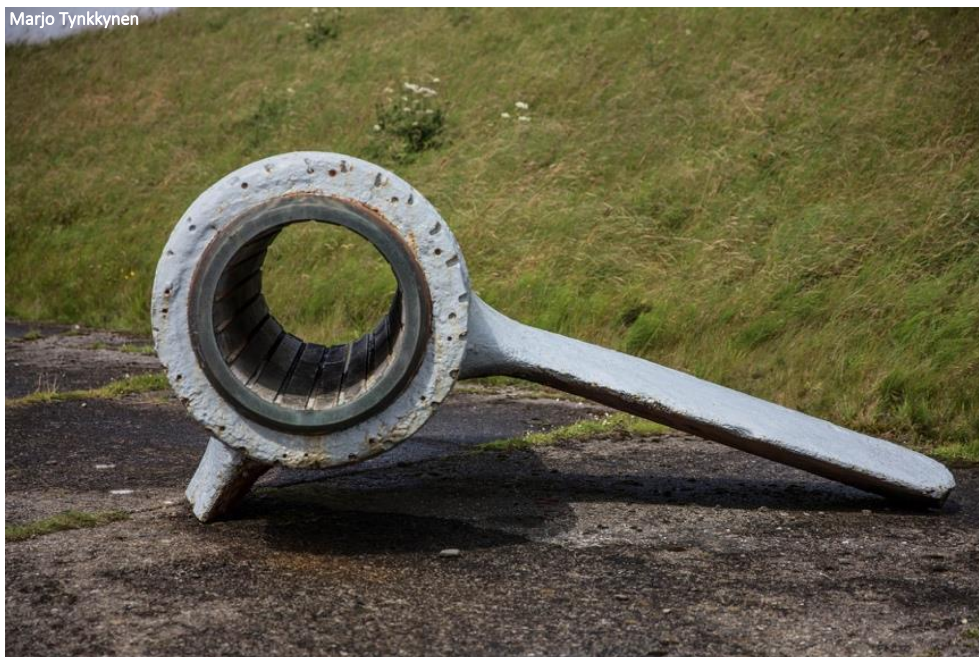
- The starboard side A-frame was also recovered with the propeller and has associated damage consistent with fracturing.

*Figure 125: Starboard side A-frame bracket*

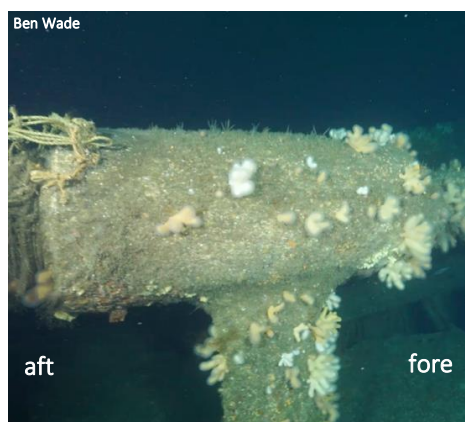
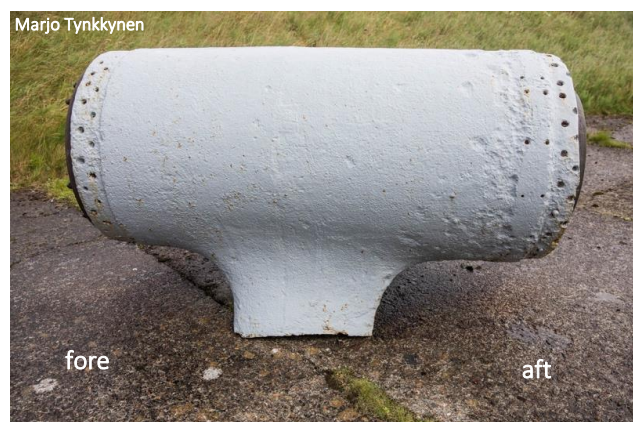
Examination of the footage of the remaining port A-frame clearly shows the cutlass bearing extends further aft than forward of its supports.

*Figure 128: Comparison of starboard and port A-frames, detailing fore and aft position*

This enabled us to orientate the A-frame and bearing at Lyness, such that the remaining short arm was the upper leg on the ship. The remaining long leg would have been attached to the keel.

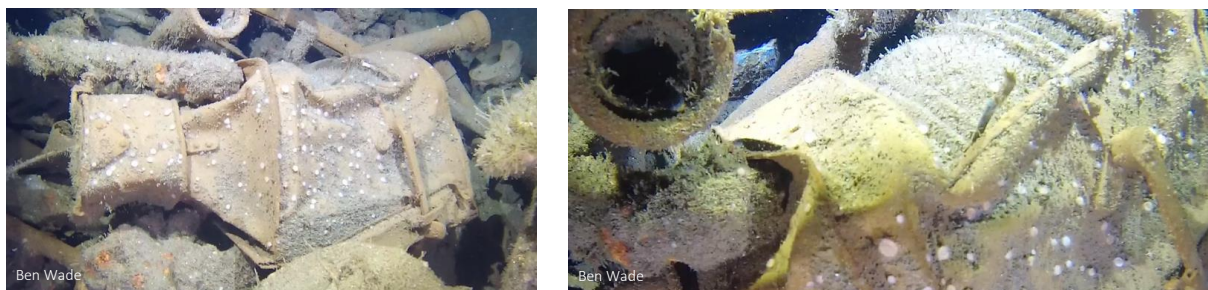
An intact navigation lamp showing possible compression damage from sinking lies in the bow. The glass is intact in the lamp. These were likely held in the boatswain's store which, on the ship's plans, is marked in this part of the bow. In addition to the pressure damage visible on the navigation lamp in the bow, several dozen ribbed brass cordite propellant storage boxes also show evidence of pressure damage consistent with all propellant boxes located on the wreck. Nowhere was there evidence found of explosive damage to the boxes.

*Figure 129: Intact navigation lamp*

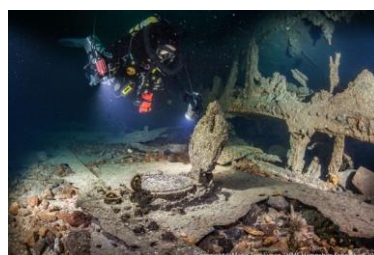
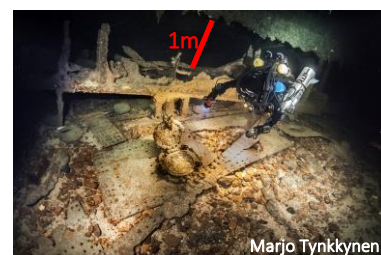
The Main Deck, which is only visible on the port side, has reduced in deck to deckhead height from 2.5 metres at her time of construction to approximately 1 metre at the time of the survey, as shown in Figure 130. It is noteworthy that this has remained stable, and does not seem to have decreased considerably between the 1999 and 2016 images. The associated hull plating along the midships section has fallen away and now lies face down on the seabed.

*Figure 130: Hull plating*

The hull plating fallen to the seabed outside the wreck contains portholes from the Main Deck. These were mostly in situ circa 2000.

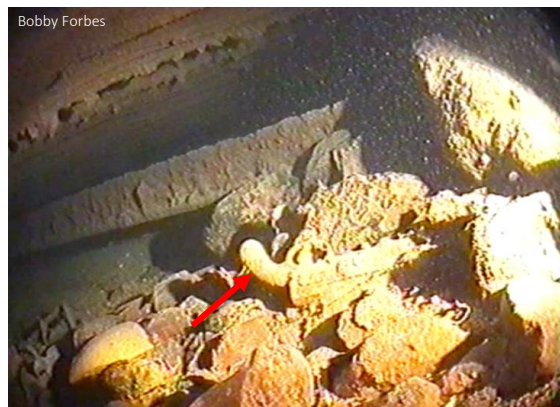
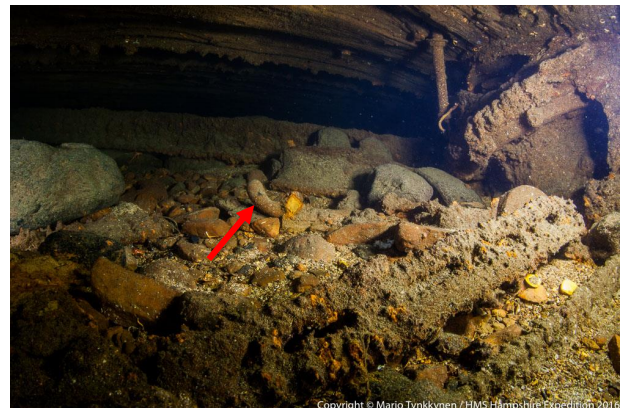
With the decay of the Main Deck, the vertical armour belt was able to settle towards the seabed under its own weight. This process has allowed the port side fissure to form at the weakest part of the hull structure, which is now above the vertical armour belt and armoured deck, in her capsized form. This decay may have been exacerbated by a longitudinal ammunition passageway running the entire length of the midships section.

Figure 131: Images comparing distance between upturned hull and seabed. Note Vickers gun firing trigger

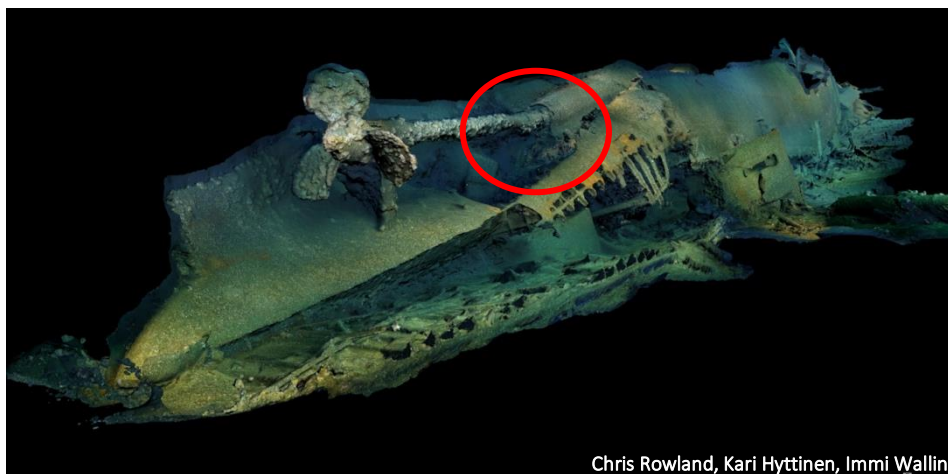
The stern section has suffered severely from saltwater corrosion and decay. The Main Deck and Lower Deck have mostly rotted away, leaving only the Platform Deck and the Hold relatively intact. The Platform Deck is supported by the armoured deck at seabed level while the keel is supported by Y-turret's ammunition hoist. The port side propeller and shaft remain intact, although the shaft is showing signs of stress at the stern tube where circled in red, below. It is anticipated that this will snap over the course of time.

*Figure 134: 3 image of port side propeller and shaft*
